Infrastructures near Seismic Faults

Infrastructures near Seismic Faults: Data archives prepared by the Technical Committee for Fault-related Geotechnical Issues about Civil-infrastructures, Japan Geotechnical Society (JGS).

REPORT OF JSPS RESEARCH PROJECT
2006 GRANT-IN-AID FOR SCIENTIFIC RESEARCH (A)
Project No. 16208048
Title of the Project:

Key Points for Rational Design for Civil-Infrastructures near Seismic Faults Reflecting Soil-Structure Interaction Features

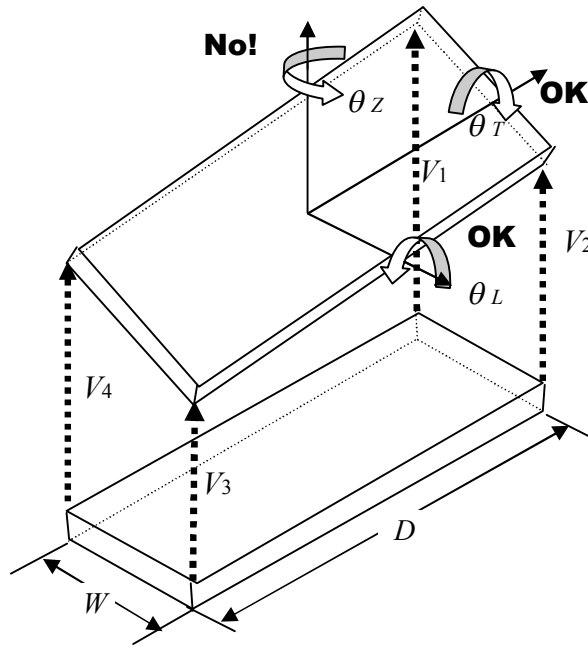
Pile caps on the foot wall side have shifted about 4 to 8 cm away from the fault trace suffering a slight tilts of about 1.5 to 5 degrees. Beyond 100 m away from the fault, the ground subsided only a few centimeters and the piles had no visible damage.

Since only vertical displacements were measured at four corners of every pile cap for the main viaduct, rotations of these pile caps θ_L and θ_T around both two orthogonal axes in a horizontal plane but not around the upright axis were calculated (**Fig. 2.15** and **Table 2.4**). In general, the pile caps for the main viaduct were rotated slightly westwards. Among them, MP2 has experienced the largest rotation of about 1.40%. Abutment MA2 showed the second largest westwards rotation of about 0.82% though it was the farthest among the others from the estimated fault trace. The abutment was under construction, and did not retain its back fill at the time of the earthquake.

Fig. 2.15. Pile cap rotations around two orthogonal axes in the horizontal plane.

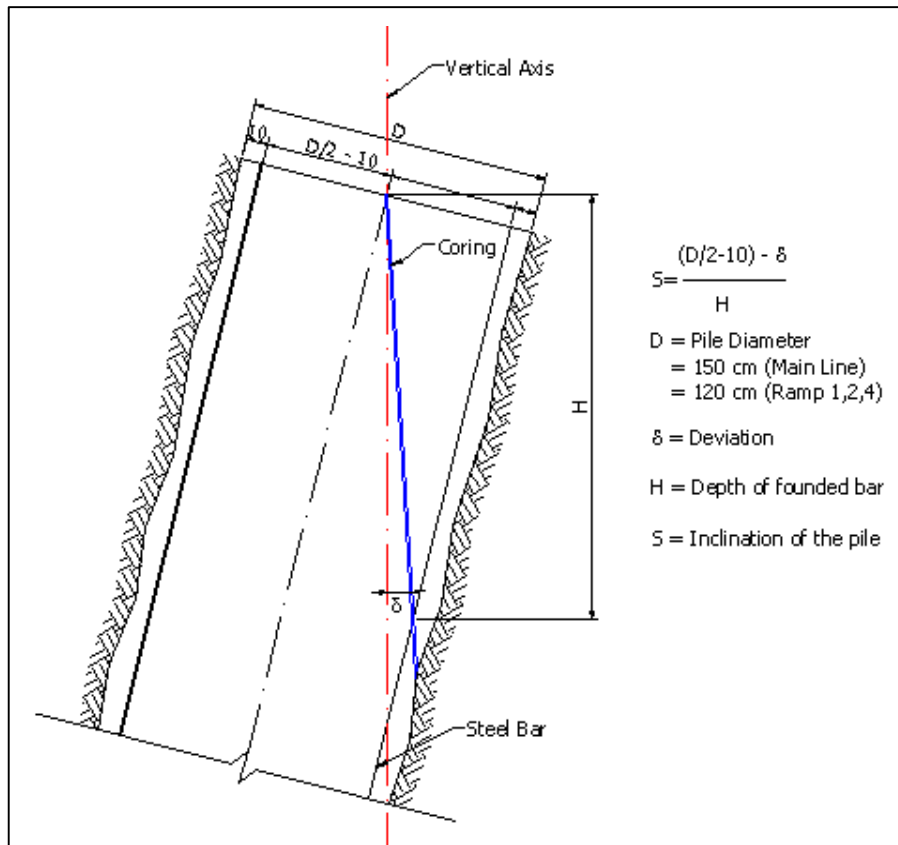
After the earthquake, piles integrity became one of the major concerns towards continuing construction of the highway viaducts, and direct coring of piles was made at pile caps (MAA 2000, Chen et al. 2003). A triple tube coring system (diameter: 64mm) was used to ensure efficient and reliable core drilling minimizing frictional disturbance. Total 27 piles were subjected to coring and total 547m-long cores were sampled. At every pile cap, one corner pile was taken among those making up a group beneath their cap. Coring started from the center of the top end of the selected pile until the drill went through the pile's bottom and farther 1 m down into the soil, and it was often that the drill reached the side soil before reaching the bottom; the fact indicating that the pile was inclined near the fault rupture plane. There were 11 piles found tilted. Measuring and adjusting errors due to unavoidable inclination of coring through concrete, average inclinations of piles were calculated by dividing the distance from pile's center to the position of side reinforcing bars by the length of the drilled core above the point where the drill hollowed out a part of the side reinforcing bars (see Fig. 2.16). In this estimation, there was nothing to hint the direction of tilt, but pile caps' rotations are considered to be consistent with the tilts of these piles, namely piles are considered to have tilted east. Cores of 6.4 cm in diameter taken from piles were examined for a careful mapping of cracks.

Fig. 2.16: Coring of pile for locating cracks and measuring pile's inclination

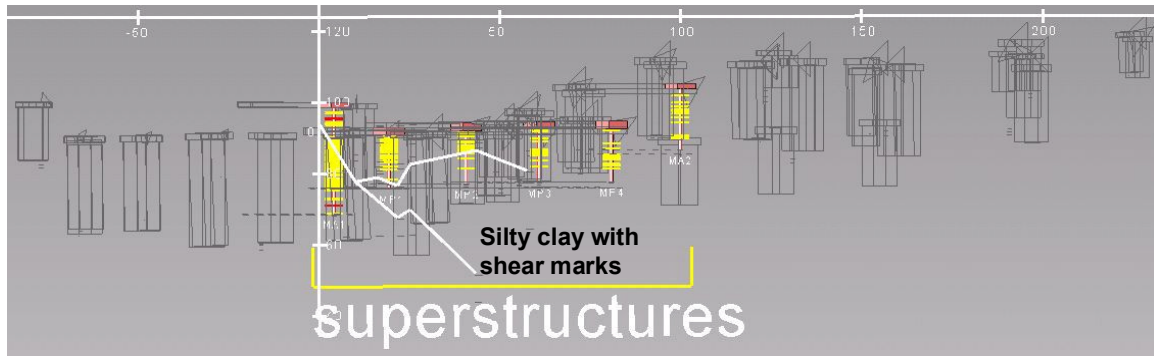
Taking into account fault rupturing process, the piles could have experienced dynamic inertia interaction first, which was then followed by rather slow kinematic interaction due to fault-induced large soil deformation. Eventually pile-cap interface cracked due to the inertia interaction can be moment-free, and the pile cap will be moved by the piles experiencing slow and steady soil deformations. To discuss possible pile caps movements near a seismic fault, which movements can affect the function of their viaduct; due attentions should be paid to this scenario.

Fig. 2.17. Location of cracks in cores from piles for the main viaduct piers and abutments looking from south to north in the direction of along the estimated fault trace: This figure is prepared from the 3D model of Bauweishan, displaying Layers “2D-main Post EQ”, “captions-main”, “cracks-main”, “scale” and hiding the others. Cracks are densely distributed within the surface stratum of natural sand and gravel covered up with fills from the time of construction. These piles sustained piers when the Chi-Chi Earthquake occurred.

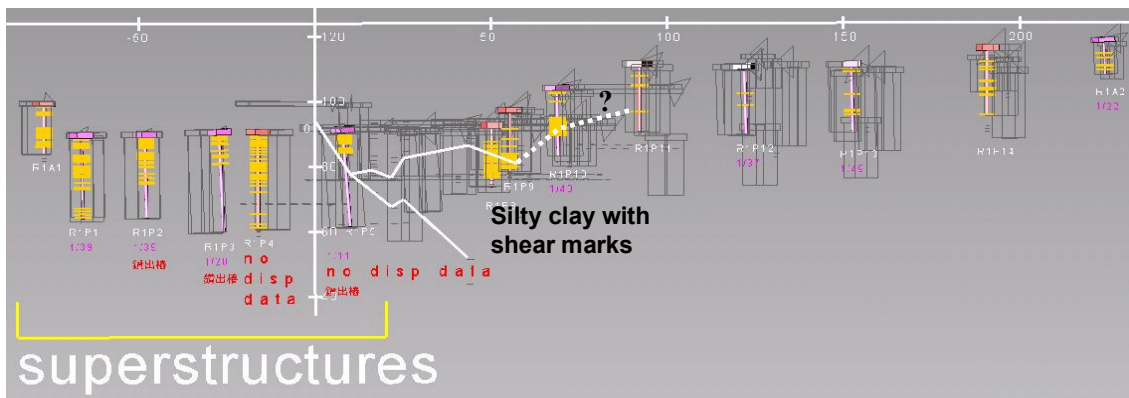
Fig. 2.18. Location of cracks in cores from piles for the Ramp #1 viaduct piers and abutments looking from south to north in the direction of along the estimated fault trace: This figure is prepared from the 3D model of Bauweishan, displaying Layers “2D-ramp1 Post EQ”, “captions-ramp1”, “cracks-ramp1”, “scale” and hiding the others. It is remarkable that piles near the estimated fault, regardless of their locations on either hanging wall side or foot wall side, were severely cracked. However those on the hanging wall side appeared rather deeper locations and seemingly close to boundary between the surface stratum and the silt-clay wedge with shear marks. The farther the piles were on the hanging wall side, the sparser the cracks were. Note those on the hanging wall side sustained no pier when the earthquake occurred.

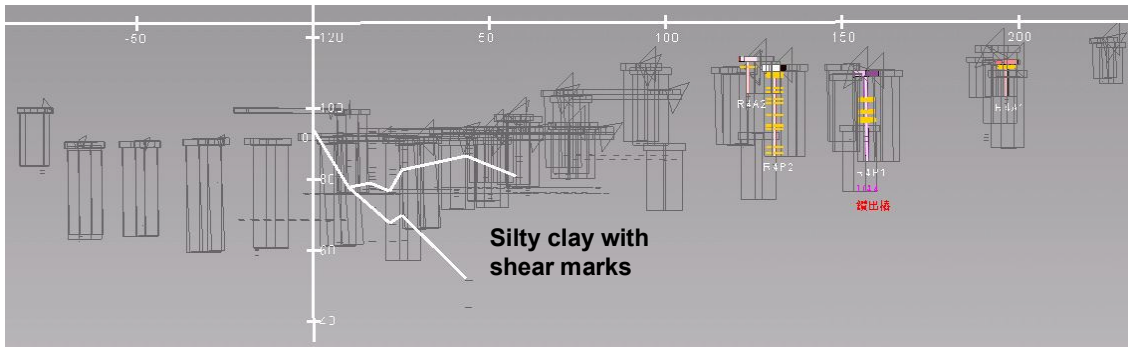
Fig. 2.19. Location of cracks in cores from piles for the Ramp #4 viaduct piers and abutments looking from south to north in the direction of along the estimated fault trace: This figure is prepared from the 3D model of Bauweishan, displaying Layers “2D-ramp4 Post EQ”, “captions-ramp4”, “cracks-ramp4”, “scale” and hiding the others. The cracks were rather sparse as contrasted with those in **Fig. 2.17** and **2.18**.

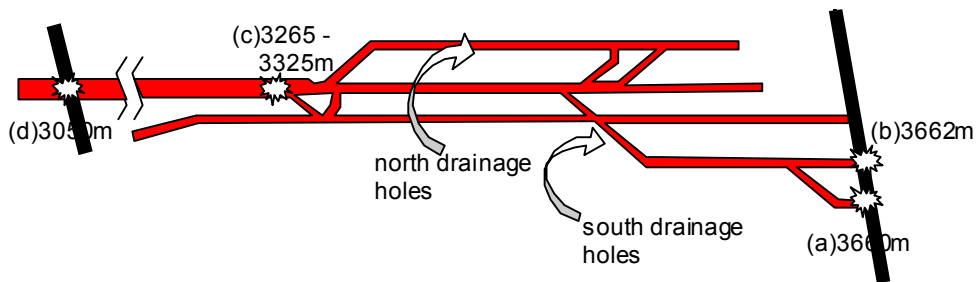
(d) Point at 3050 m from the west: A branch of the Tanna fault seems to have dislocated, and cracked the concrete lining. The east side of this point has subsided by about 23 cm.

Fig. 3.2: Drainage holes and damaged points

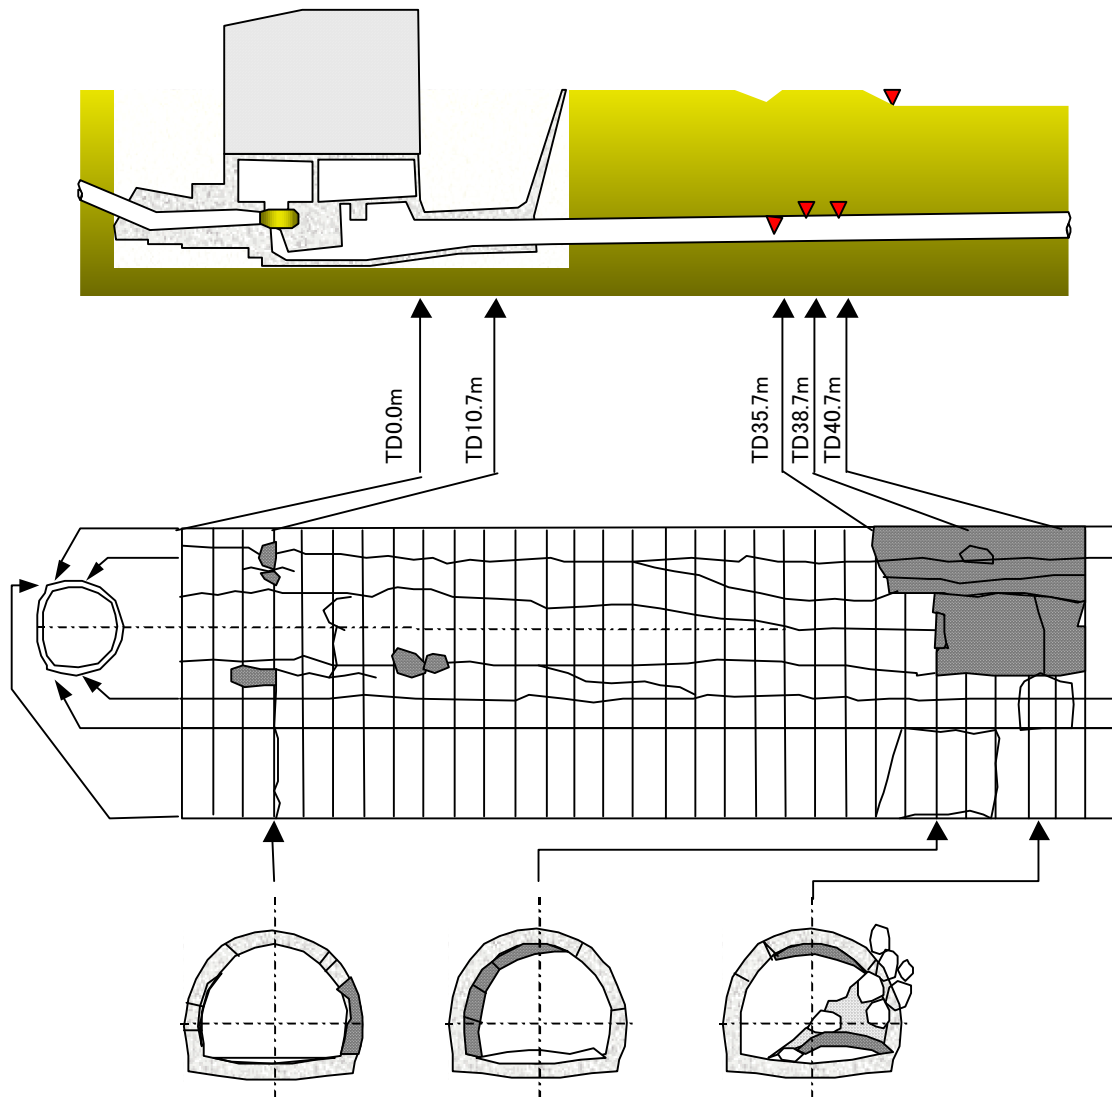
Fig. 3.9: Development and cross-sections of cracked tunnel (after Hashimoto, 1998)

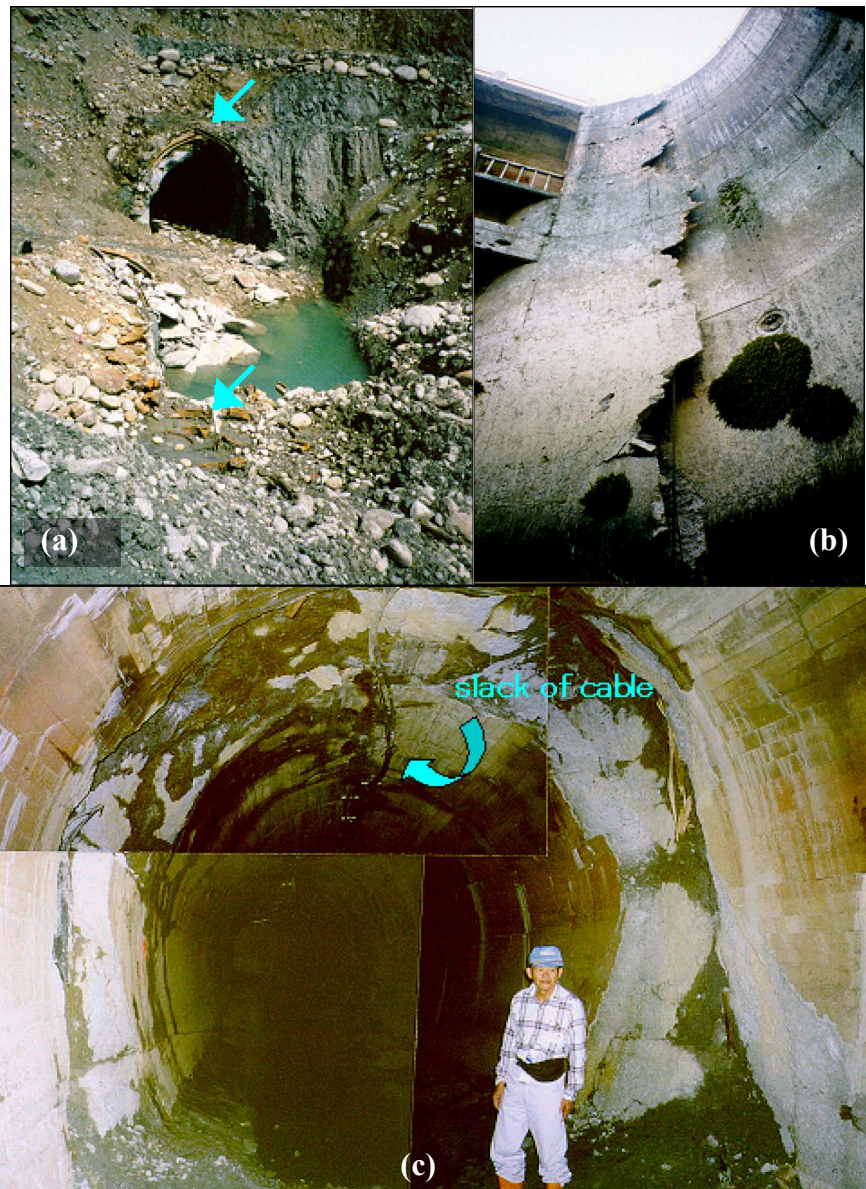
The ground rupture in the 1999 ChiChi earthquake propagated north along the recognized CherLungPu fault trace, and suddenly turned east off at Feng-Yuan city shooting many branches that crossed ShihKang area (see **Chapter 4**). One of these branches crossed the intake tunnel of the ShihKang dam, and dislocated it about 3.5 m vertically and about 3 m horizontally (**Fig. 3.11**). The tunnel has an oval cross-section, 4.1 m and 3.8 m in upright and transverse diameters. Large and small pieces of concrete came off the tunnel lining, and the slacks of the roof cable show that the tunnel experienced a large axial force. This large axial force seems to have punched out the intake gate wall by about 20 cm (**Fig. 3.11 (b)**).

Fig. 3.11: (a) Intake tunnel of the Shih-Kang dam was cut off by the fault. (b) The intake gate sheared off due to large horizontal load from the axially compressed tunnel. (c) This photo shows the cracked up interior of the tunnel.

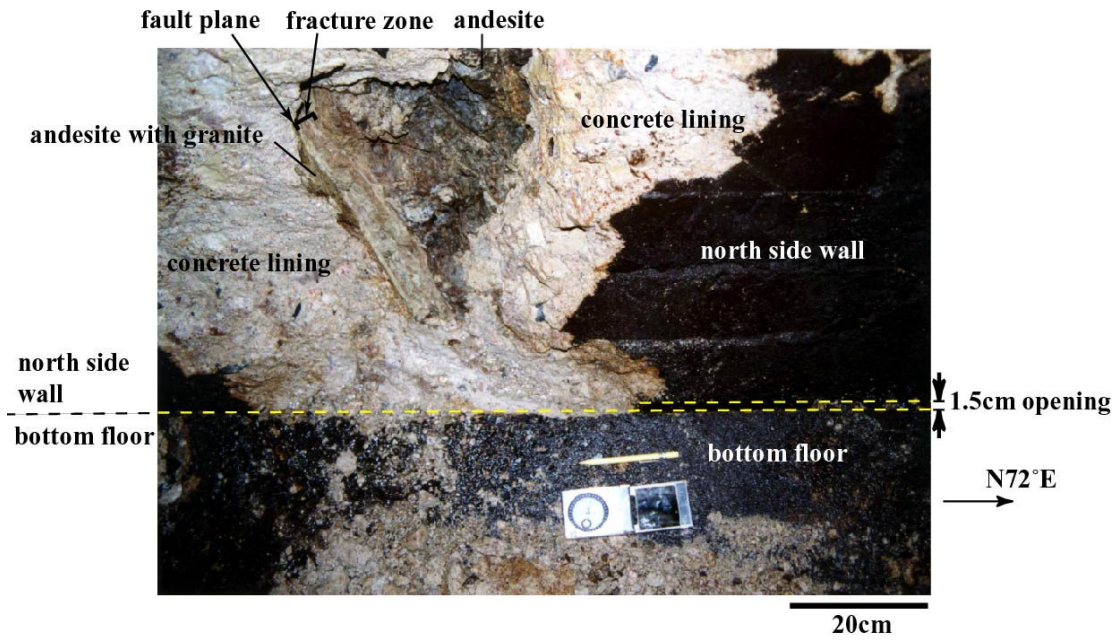
At Point A, some fragments of concrete lining came off, and a left lateral dislocation of about 2 cm was observed on the exposed rock surface (**Fig. 3.13**). Cracks were found over 7m distance as shown in **Fig. 3.14**, and the tunnel was bent over this distance by about 10 to 20 cm (**Fig. 3.15**). Cracks on the lining show conjugate features with respect to the dislocation observed on the rock. Point B located about 365m west of Point A was less seriously cracked over 4m distance.

Fig. 3.13: Dislocation found on exposed rock in Intake Tunnel of Omiya dam in the 2000 West Tottori earthquake, (Ueta 2002)

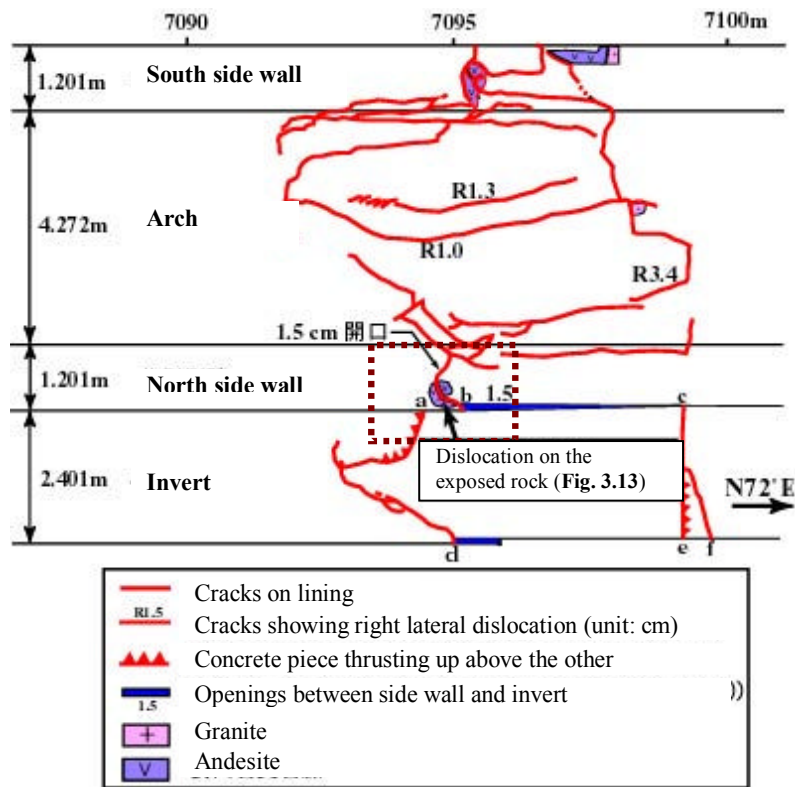
Fig. 3.14: Cracks that appeared on concrete lining, Intake Tunnel of Omiya dam in the 2000 West Tottori earthquake (Ueta 2002).

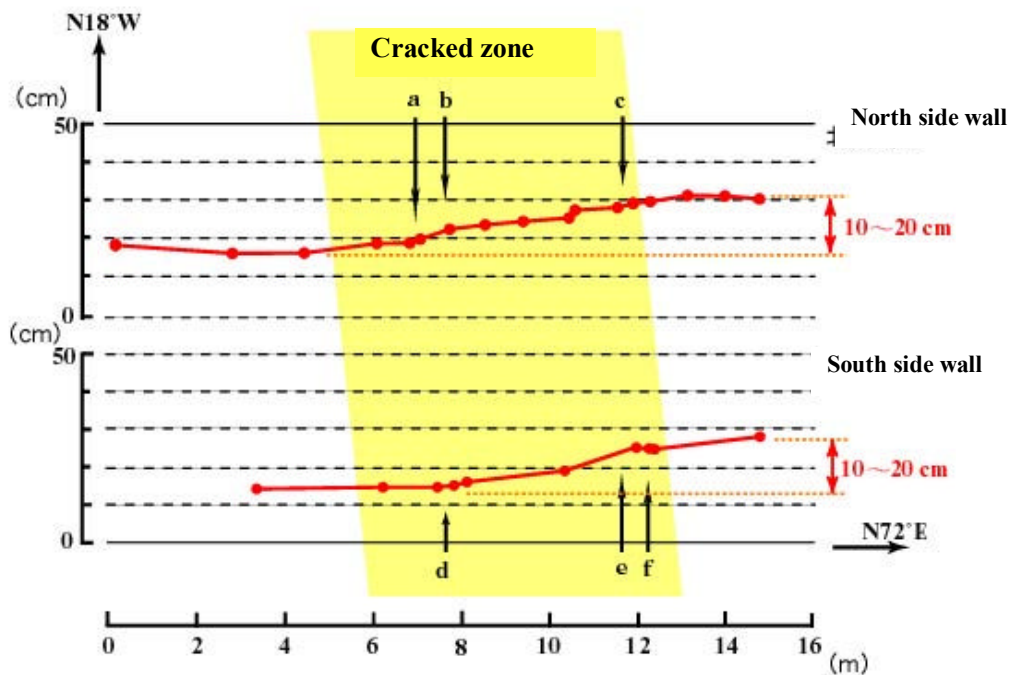
Fig. 3.15: Alignment of the Intake Tunnel of Omiya Dam deformed in the 2000 West Tottori Earthquake (Ueta, 2002)

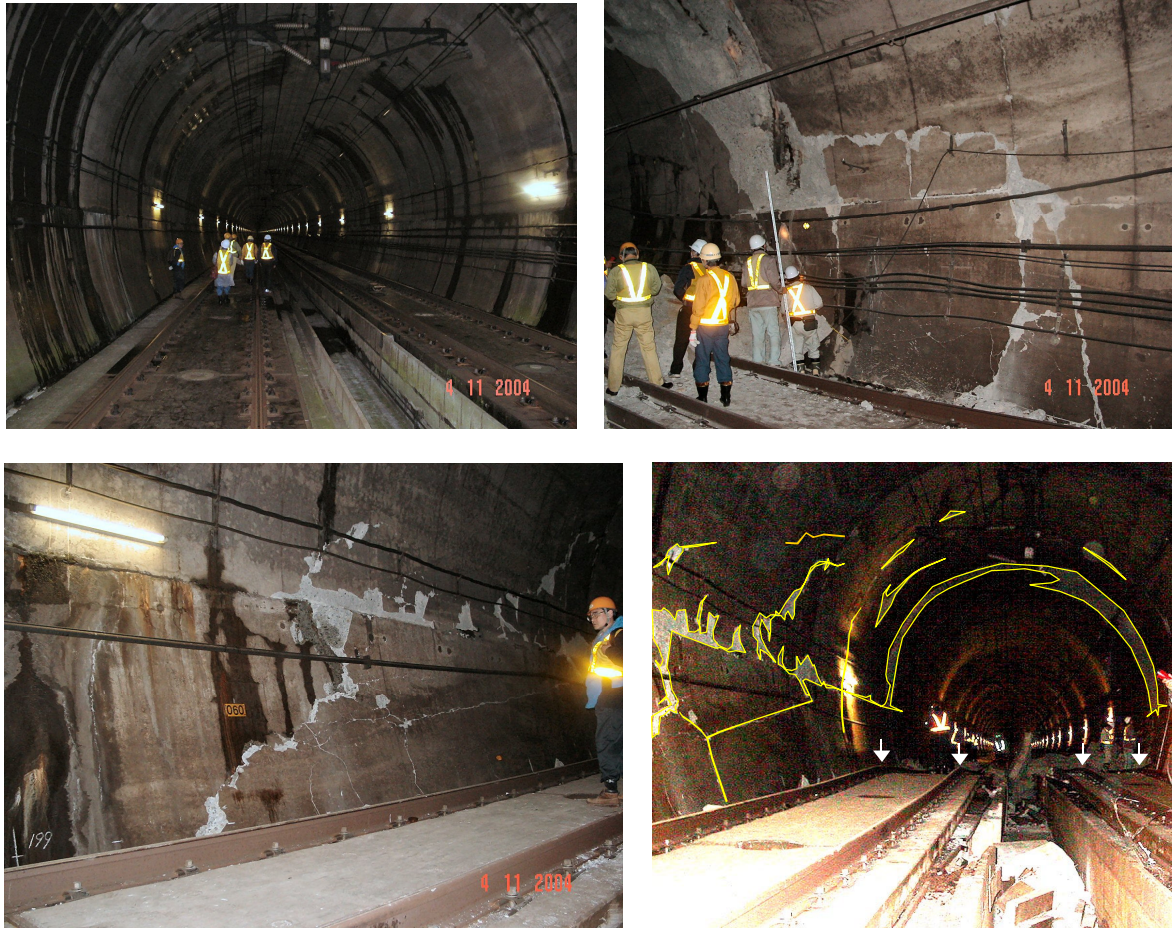
The 8625 meter long concrete tunnel was constructed with the New Austrian Tunnelling Method passing through the damaged location at a depth of 60-100 meter as interpreted from **Fig. 3.19**. **Fig. 3.19** indicates an extreme amount of leakage (200 liter/min) during the construction time. **Fig. 3.20 (a)** and **3.20(b)** show an original tunnel section and the damage location. A diagonal crack running from the south part to the central of the damaged area is marked with an orange line. The spalling of concrete block is seen in the background. A close up of the cracks are given in **Fig. 3.20(c)** and **20(d)**. With the help of tripod a crack development photos was also taken; the result is shown in **Fig. 21**. The south part of the damaged area is to the right in the figure and the central part to the left. The northern part of the damaged area has lighter damage and the rail foundation is not deformed as much as in the south part (see **Fig. 3.22**).

Fig. 3.20: a) Original section. b) Crack crossing the tunnel: white colored line. Top of rail is indicated by white arrows c) and d) Close up of cracks.

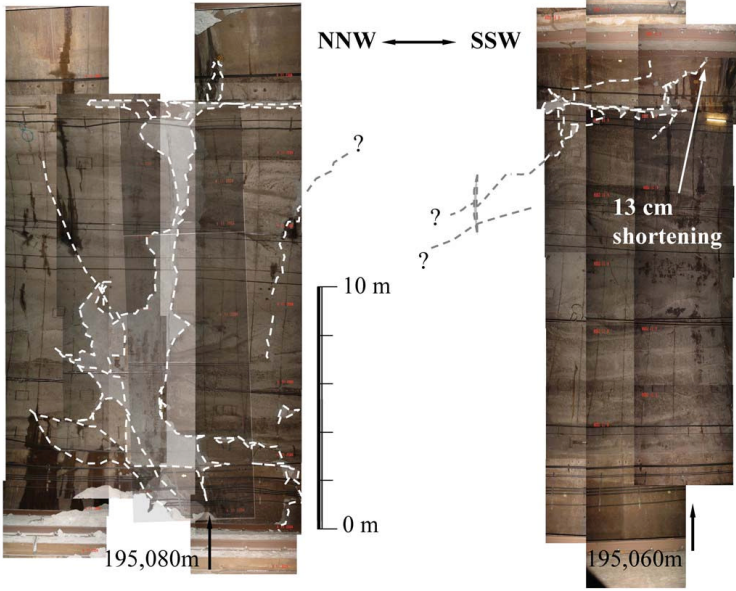
Fig. 3.21: Lining crack development of Uonuma tunnel. White dashed lines indicates crack location and shaded areas show spalling.

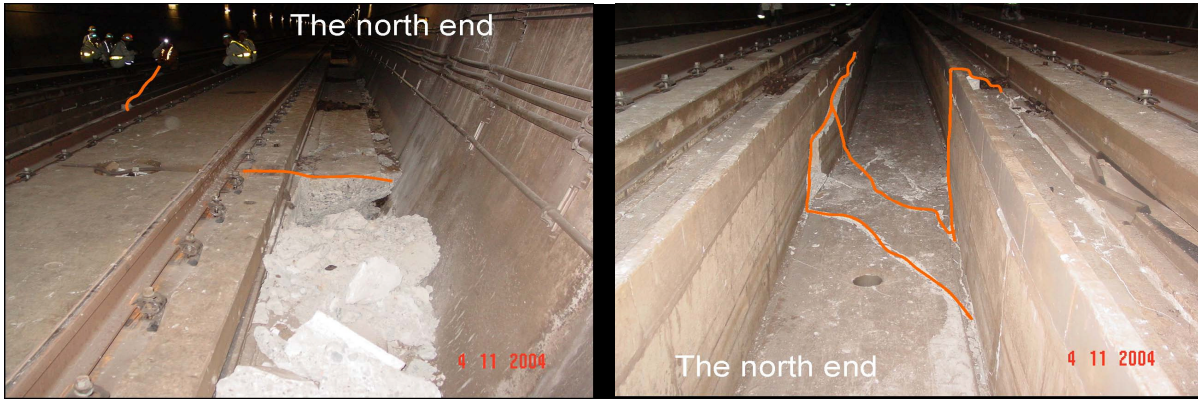
Figure 3.22: a) Cracks in the northern end of the damage area. b) close up of crack between rails (upper left corner of figure a).

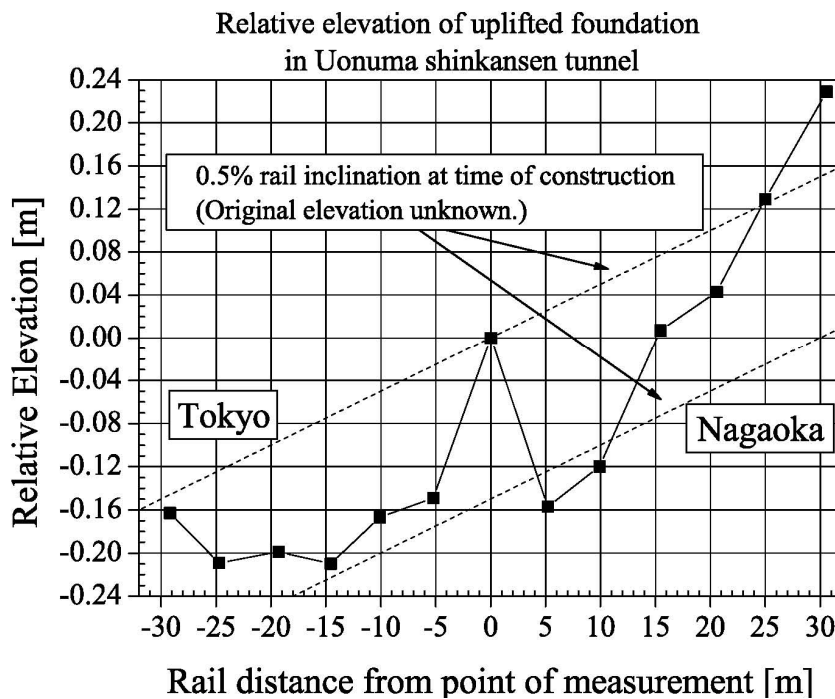
Fig. 3.23: Relative elevation of left rail (facing Nagaoka) before and after earthquake some 15-20 meters south of downfallen concrete block.

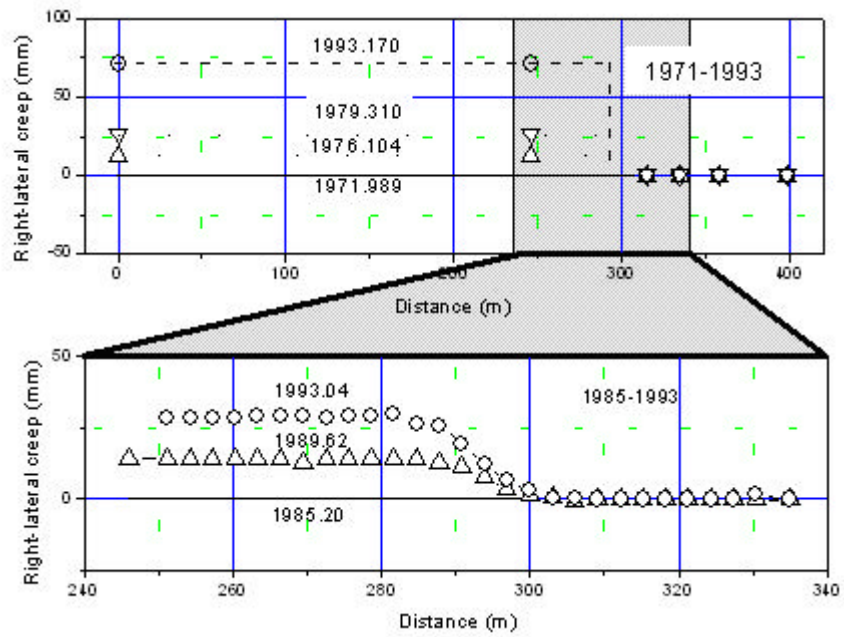
Fig. 3.26: Steady change in tunnel alignment

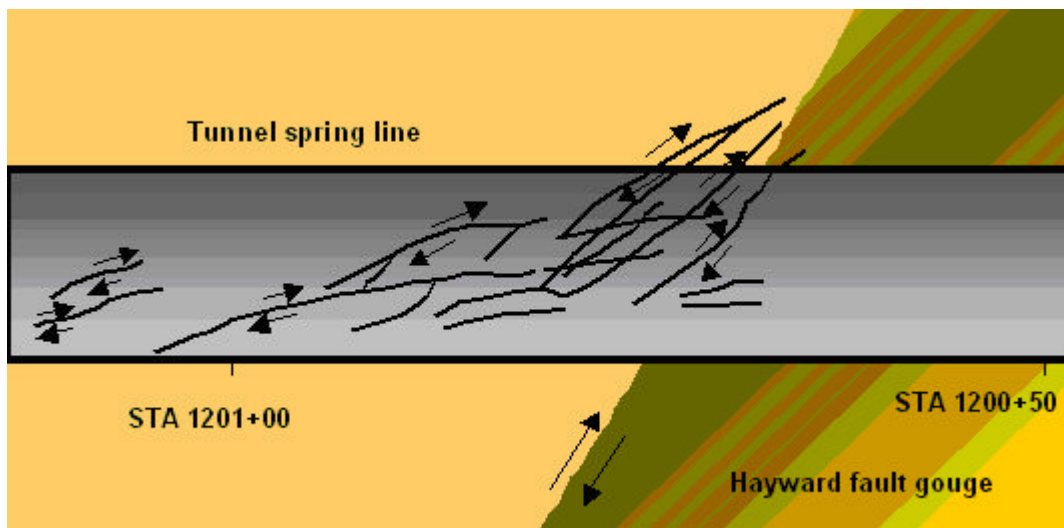
BART Contra Costa line (C line) leading to Pittsburg bores through the rock of "Barkeley-hill" east of Berkeley (**Fig. 3.25**). The Hayward fault bisects this BART tunnel about 300 m inside from the west entrance. There was a debate erupted when USGS issued a press release indicating potential for damage to structures along the Hayward fault. BART has carried out careful alignment surveys of the tunnels since their completion in 1968. The extensometer measurements were continued in the fault zones and eventually, it was found that the total 80 mm dislocation due to the right-lateral strike slip had been built up over 10 years (1971-1980) in the north tunnel; There are 2 bores, each about 22 feet in diameter, spaced 50 feet apart and linked with pedestrian cross-tunnels at a regular interval of 1000 feet for emergency evacuation. By that time (1979) low angle cracks were visible on the lining of the tunnels, suggesting the compressional force along the tunnel axis (**Fig. 3.27**).

Fig. 3.27: Low angle cracks appearing on the tunnel lining.

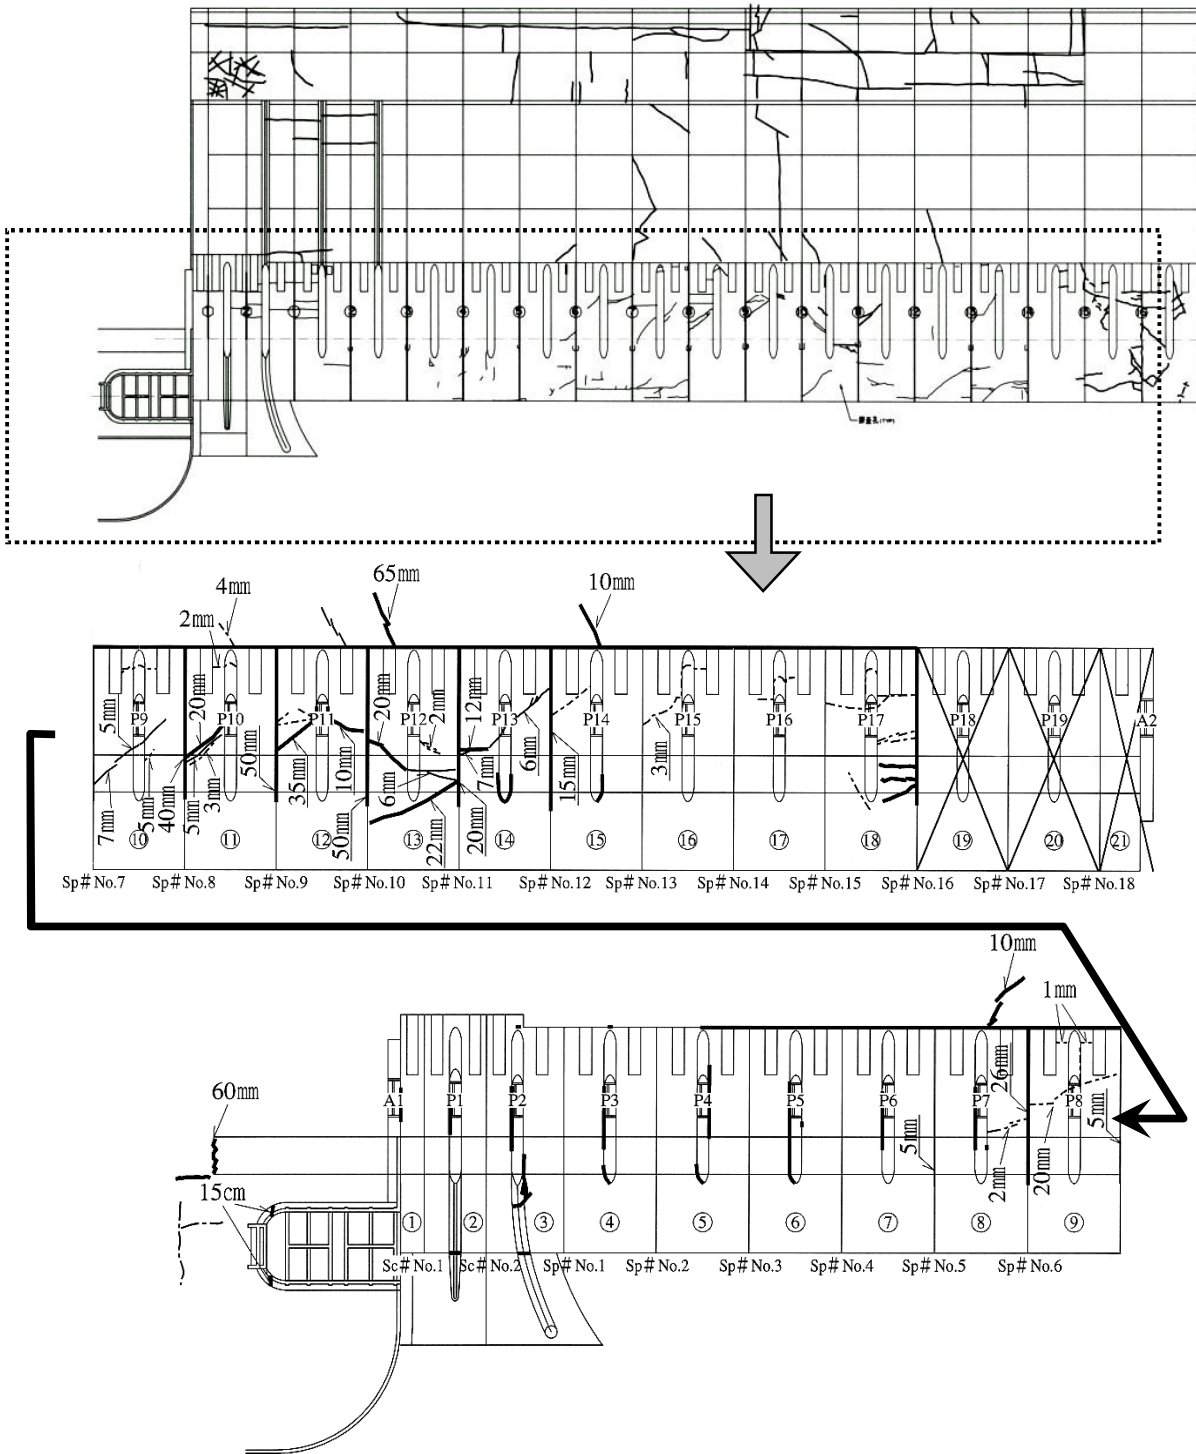
Simply supported RC bridges span all spillways and sluices. They all came off their bearings. The cracks on the dam body caused 6 gates (5 for spillways and one for sluice) to be inoperable.

Fig. 4.11: Crack map of ShihKang dam (Sugimura et al, 1999)

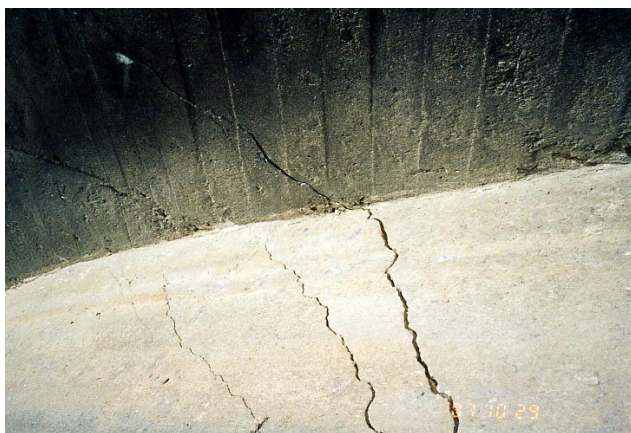
(e) Cracks extending diagonally up through Pier #10

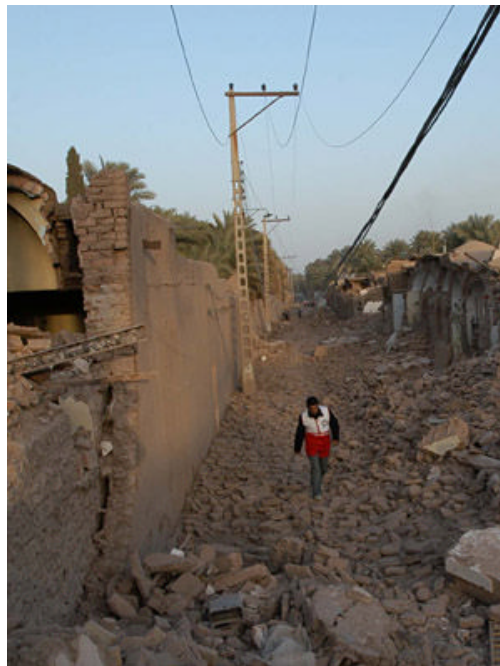
Fig. 6.2: Poles remaining upright in debris (2003 Bam Earthquake, Iran)

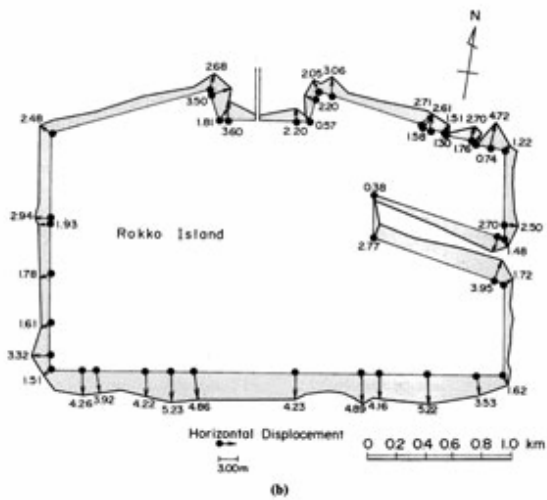
Fig. 6.4: Displacements of quay walls at Port and Rokko islands and typical damage example with settlement of backfill (Inagaki et al., 1996).

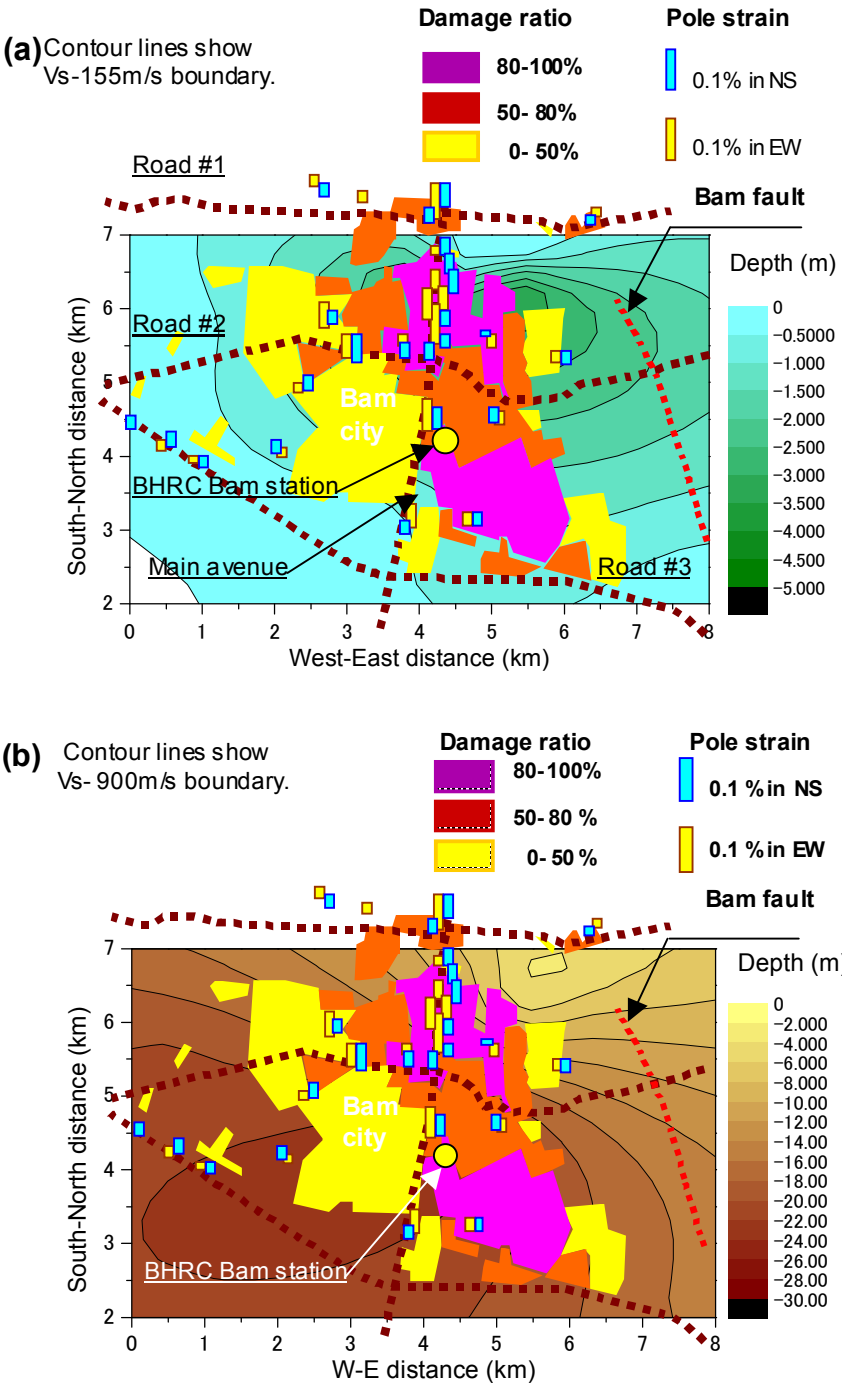
Fig. 6.22: Strains remaining in poles: (Damage distribution mapped by NCC, Iran)
