Infrastructures near Seismic Faults

Infrastructures near Seismic Faults: Data archives prepared by the Technical Committee for Fault-related Geotechnical Issues about Civil-infrastructures, Japan Geotechnical Society (JGS).

REPORT OF JSPS RESEARCH PROJECT
2006 GRANT-IN-AID FOR SCIENTIFIC RESEARCH (A)
Project No. 16208048
Title of the Project:

Key Points for Rational Design for Civil-Infrastructures near Seismic Faults Reflecting Soil-Structure Interaction Features

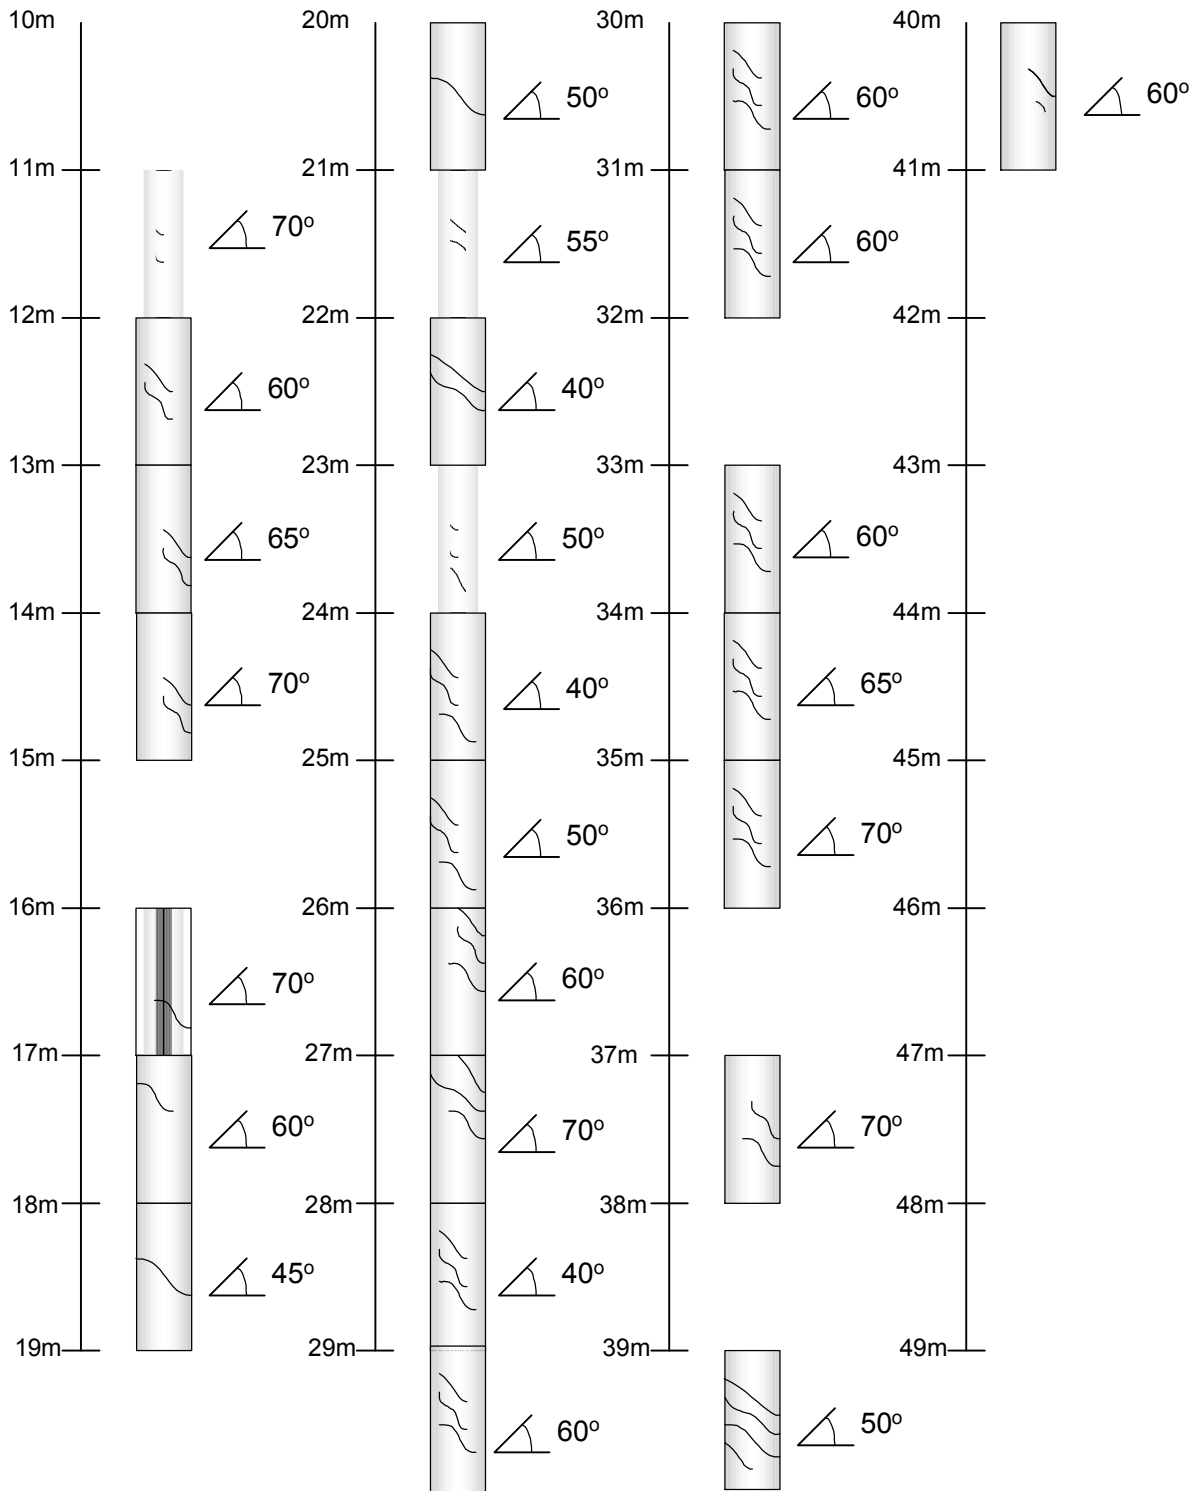
Fig. 2.4: Diagonal streak marks appearing on samples from Borehole A2

Shear Zone : 7~42 m

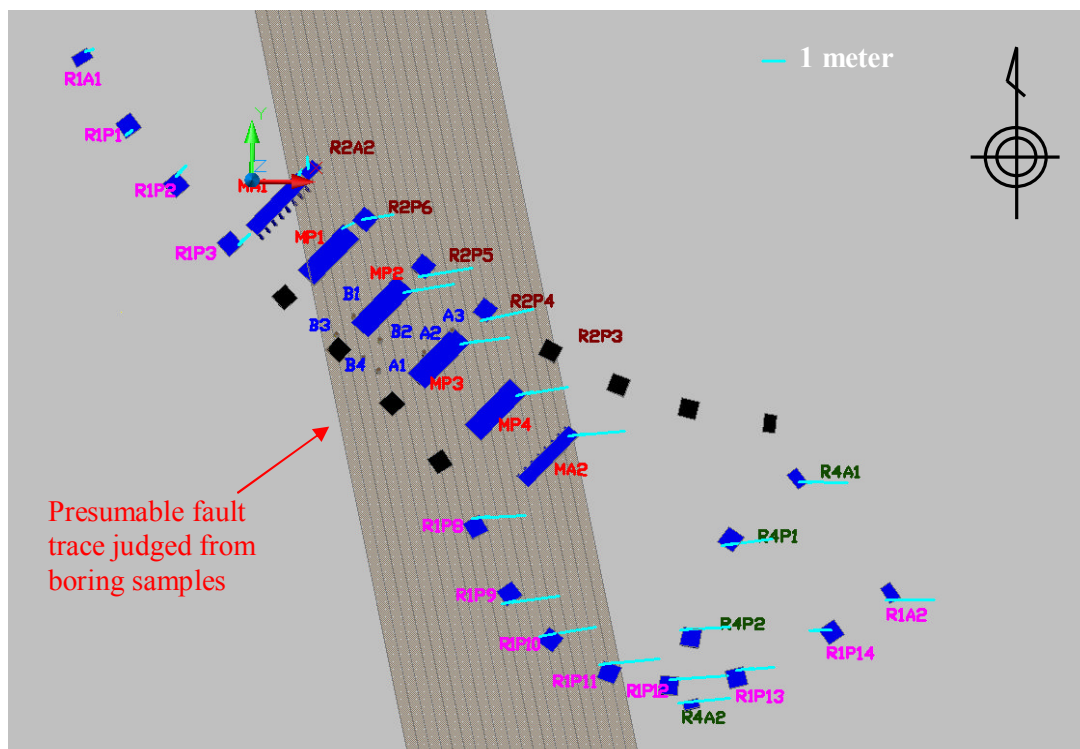
Fig. 2.12: Location of pile caps

Immediately after the earthquake, displacements of pile caps in both horizontal and vertical direction were measured at their centers. **Fig. 2.12** shows locations of pile caps. In this figure, M, R, A, and P put on pile caps stand for “main viaduct”, “ramp”, “abutment”, and “pier”, respectively. Therefore, R2P3 denotes, for example, Pier #3 of Ramp #2. Vertical displacements were obtained for the main viaduct and Ramp #1 because elevations before the earthquake were only available for those pile caps. Measured components are listed in **Table 2.3**.

Pile caps centers on the hanging wall side were displaced all at once about 2.5 m laterally in the normal direction with respect to the estimated fault trace (**Figs. 2.12** and **2.13**). For vertical components, the scatter of vectors is a little too large to conclude that all piles on the hanging wall were pushed up altogether in the same direction to be sure, but displacement vectors near the fault trace seem to be parallel to the presumable fault plane (See **Fig. 2.13**).

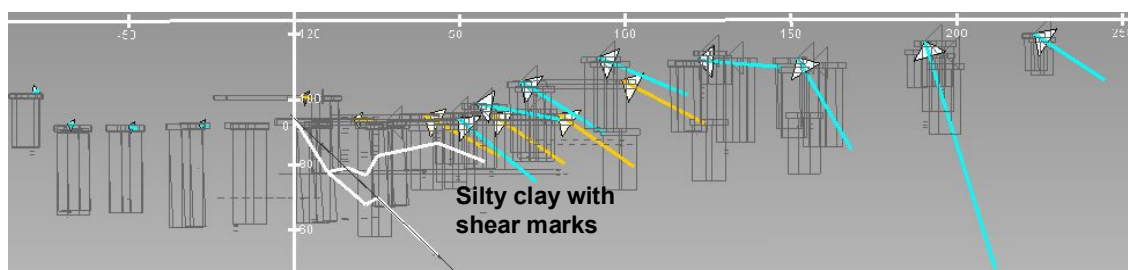
Pile caps on the foot wall side have shifted about 4 to 8 cm away from the fault trace suffering a slight tilts of about 1.5 to 5 degrees. Beyond 100 m away from the fault, the ground subsided only a few centimeters and the piles had no visible damage.

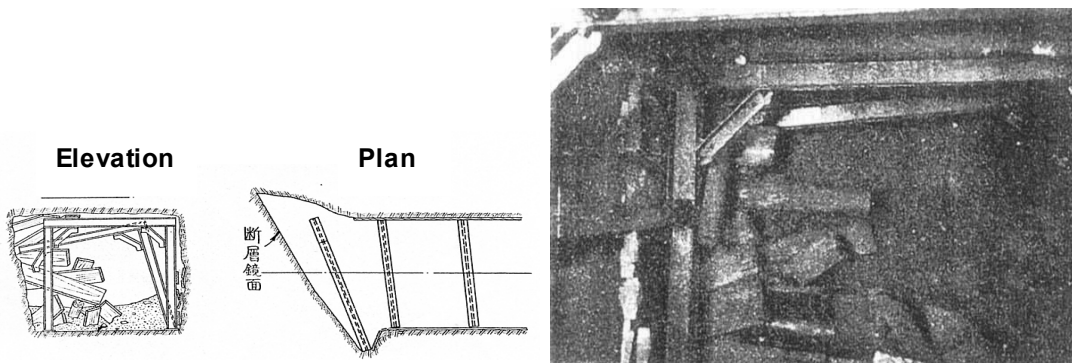
Fig. 3.3: Drainage hole #3

(a) & (b) Cut surfaces of two drainage holes, South #2 and #3, reaching the fault rupture surface at 3660m and 3662m depths respectively from the western entrance (Fig. 3.2): Since these tunnels were pushed through a fractured rock, they were needed to be supported soon after the excavation. In Drainage hole #3, Pi-shaped steel frame were quickly set up at a regular interval of about 1.5m, and the wall was then boarded up with many pieces of wood. The dislocated rock drew both the end frame and several pieces of wood into the mountain. **Fig. 3.3** shows the cut surface of Drainage hole #3. Several pieces of wood were seen half embedded in the left side of the rock.

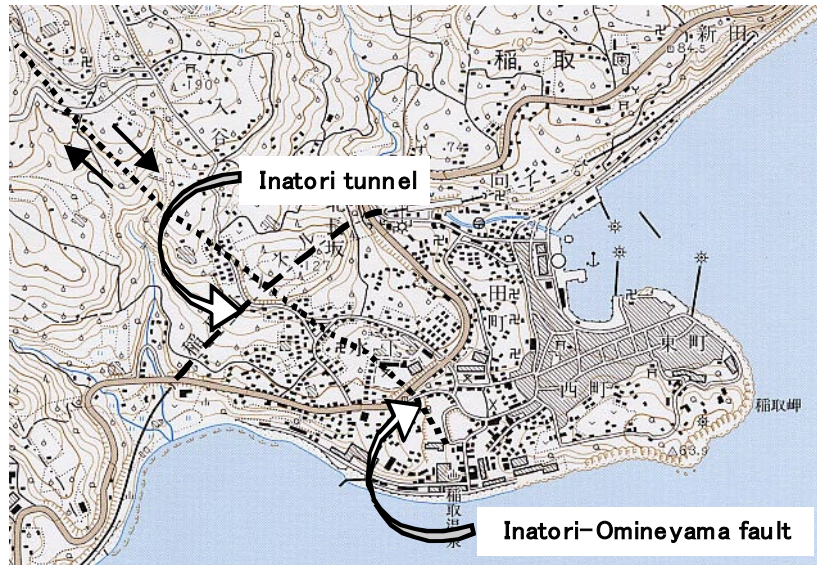
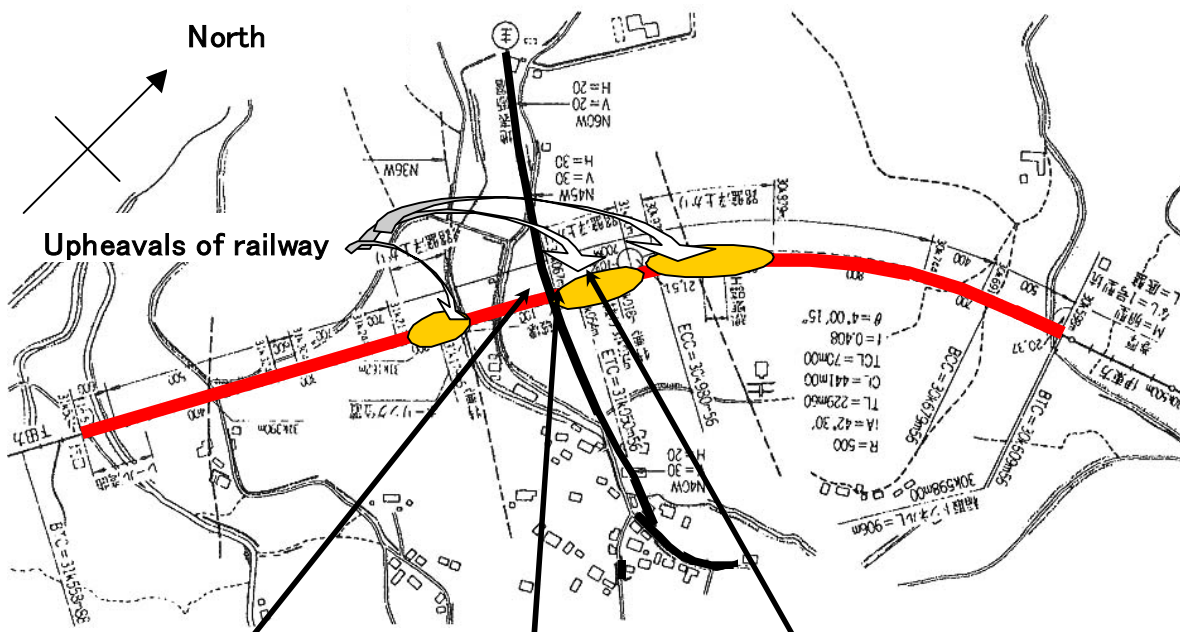
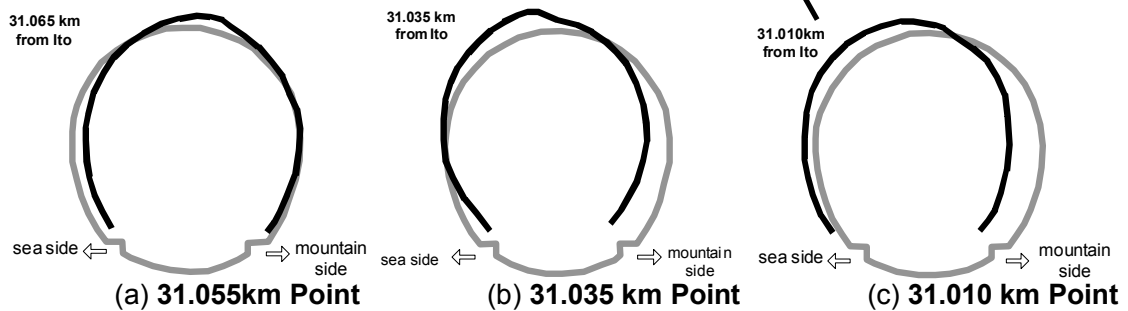
Fig. 3.4. Deformed cross sections of Inatori tunnel

A fault appeared in the 1970 Off Izu Oshima Earthquake (M7.0) across Inatori railway tunnel (906 m long) of the Izukyu line (**Fig. 3.4**). The northeastern half of the tunnel was pushed seaside, and an 85 cm lateral displacement was reached at the east mouth of the tunnel, while its western mouth was pushed about 20 cm up. The tunnel was the most seriously deformed at around the point where the tunnel was cut by the fault. **Figs. 3.4(a), (b)** and **(c)** show cross-sections at 31.055km, 31.035 km and 31.010 km points from Ito (North starting station of the Izukyu line) respectively. These cross sections were all pushed slightly out of shape exactly like those of a kinked water hose. As the consequence, crowns were bent up against soils, and some parts of their inner surfaces broke up into flakes. Some sidewall blocks were thrust forward lying between two less deformed blocks. Some invert concrete blocks were pushed up. Though cracked, the lining fortunately held the soil pressure probably because the surrounding soils had been softened by solfataric and/or hydrothermal activities.

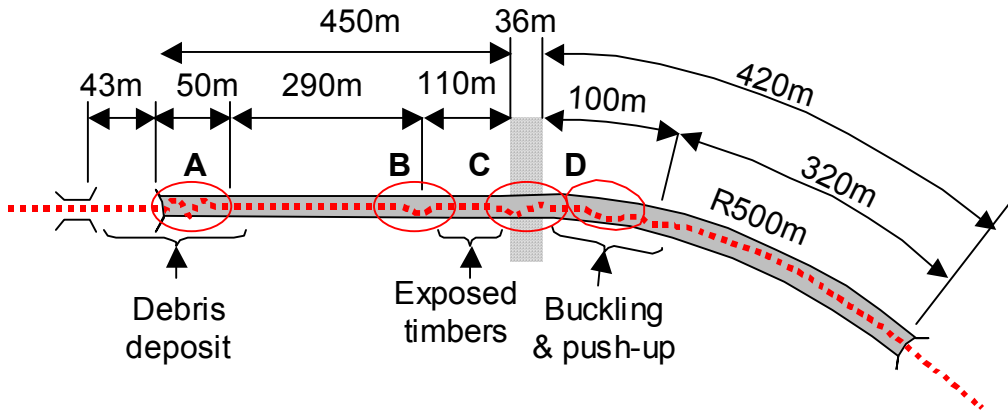
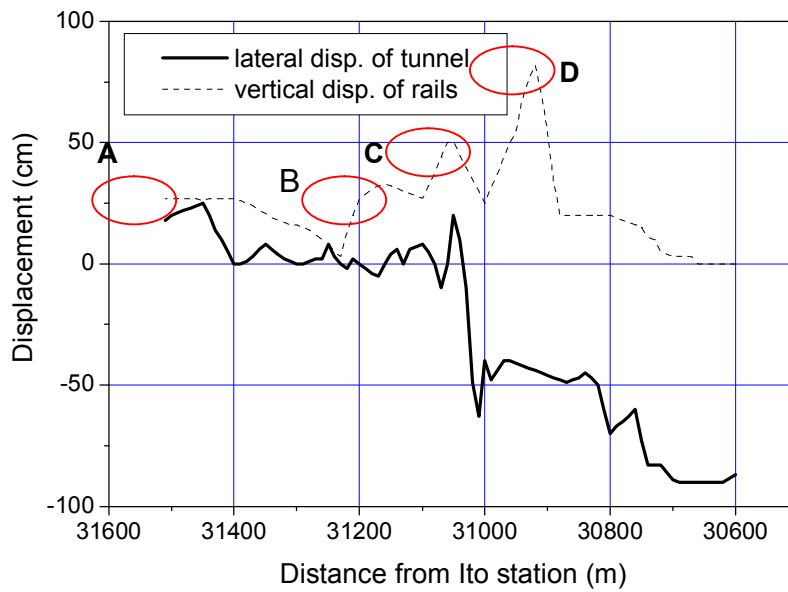
Fig. 3.5: Buckled rails and tunnel deformation

Rails were buckled at several points (**Fig. 3.5(a)**). The biggest buckling was found at **Point A**, near the southwestern mouth of the tunnel where the tunnel goes through a debris deposit. Assuming that the shape of the buckled rail is expressed as:

Overall strain of about 0.00114% was calculated for the total 50m buckling at Point A (**Fig. 3.6**). This overall strain, however, may not reflect the strain of the soil supporting the rail. A rail buckling often takes place where ties are exposed and the rail loses its lateral support. **Fig. 3.5(b)** shows that rails were buckled where they were pushed up. The overall strain thus depends greatly on the distance where rails were lifted off their subsoils. As for **Point A**, one can say that there was about 5.7 cm shortening of the subsoil.

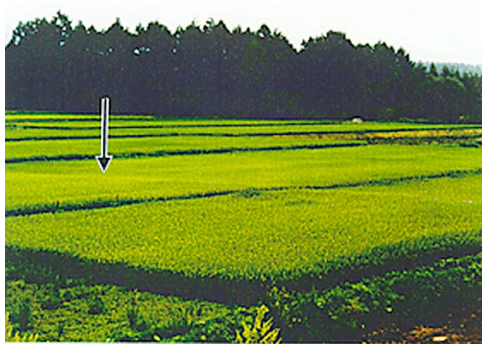
(b) Fault mark appeared in paddy field

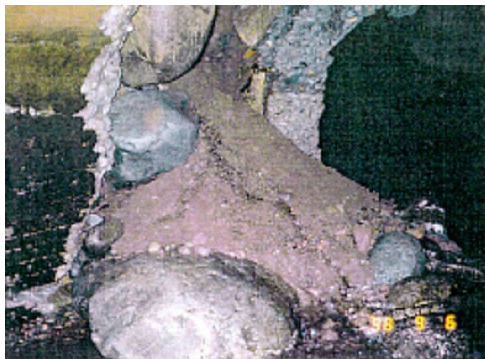
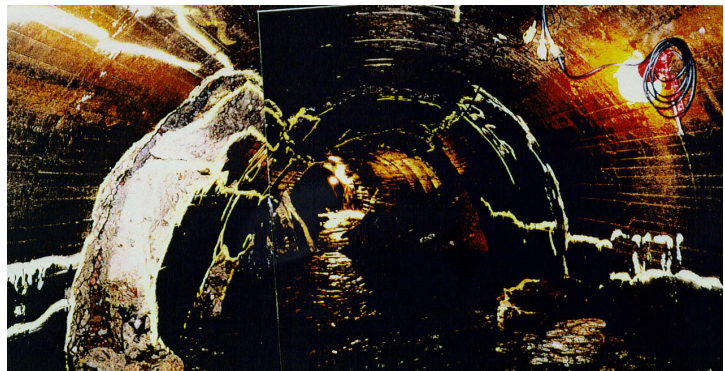
Fig. 3.10: Outlet tunnel of 2nd Kakkonda Hydropower station
(Photo: Tohoku Electric Power Co. Ltd.)

(a) Boulders squeezed into tunnel

(b) Cracked tunnel

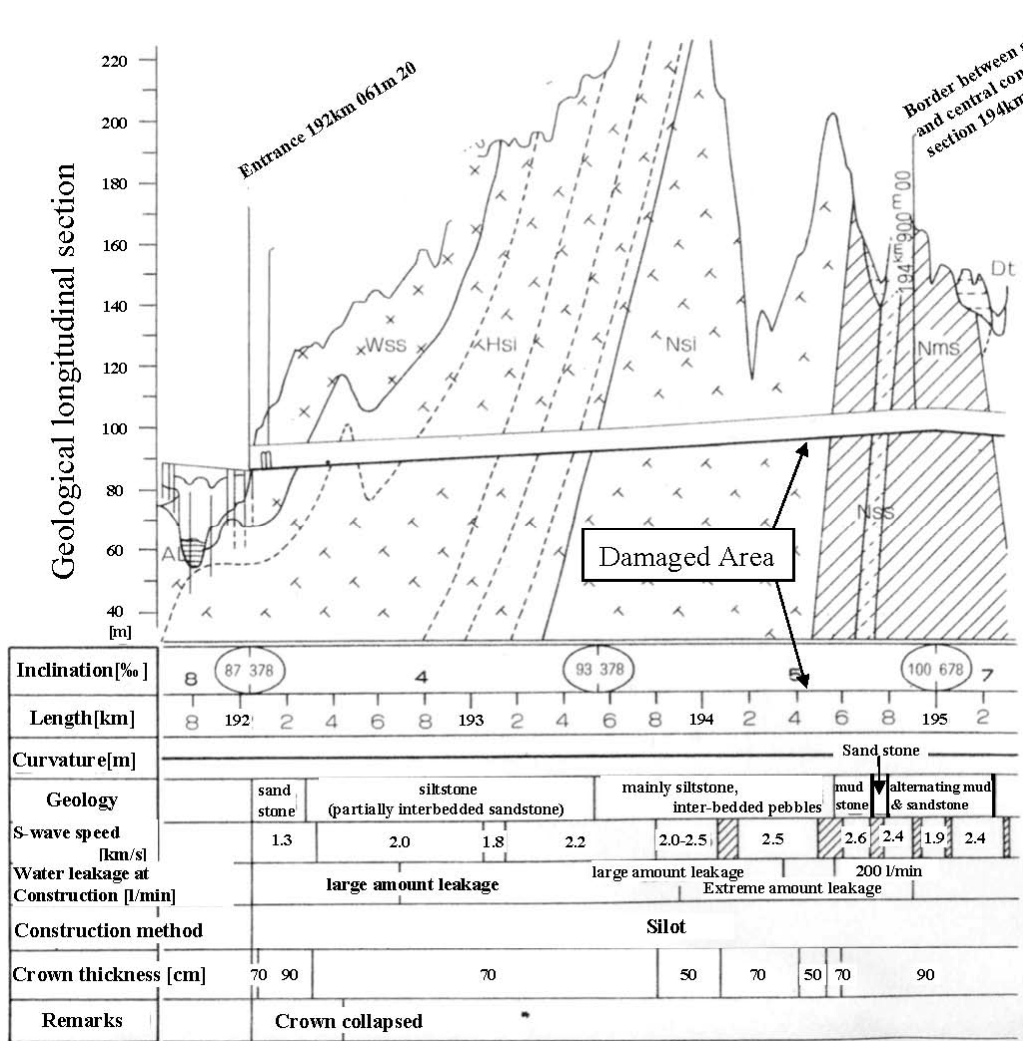
Fig. 3.19: Geological longitudinal section for the southern construction section

The 8625 meter long concrete tunnel was constructed with the New Austrian Tunnelling Method passing through the damaged location at a depth of 60-100 meter as interpreted from **Fig. 3.19**. **Fig. 3.19** indicates an extreme amount of leakage (200 liter/min) during the construction time. **Fig. 3.20 (a)** and **3.20(b)** show an original tunnel section and the damage location. A diagonal crack running from the south part to the central of the damaged area is marked with an orange line. The spalling of concrete block is seen in the background. A close up of the cracks are given in **Fig. 3.20(c)** and **20(d)**. With the help of tripod a crack development photos was also taken; the result is shown in **Fig. 21**. The south part of the damaged area is to the right in the figure and the central part to the left. The northern part of the damaged area has lighter damage and the rail foundation is not deformed as much as in the south part (see **Fig. 3.22**).

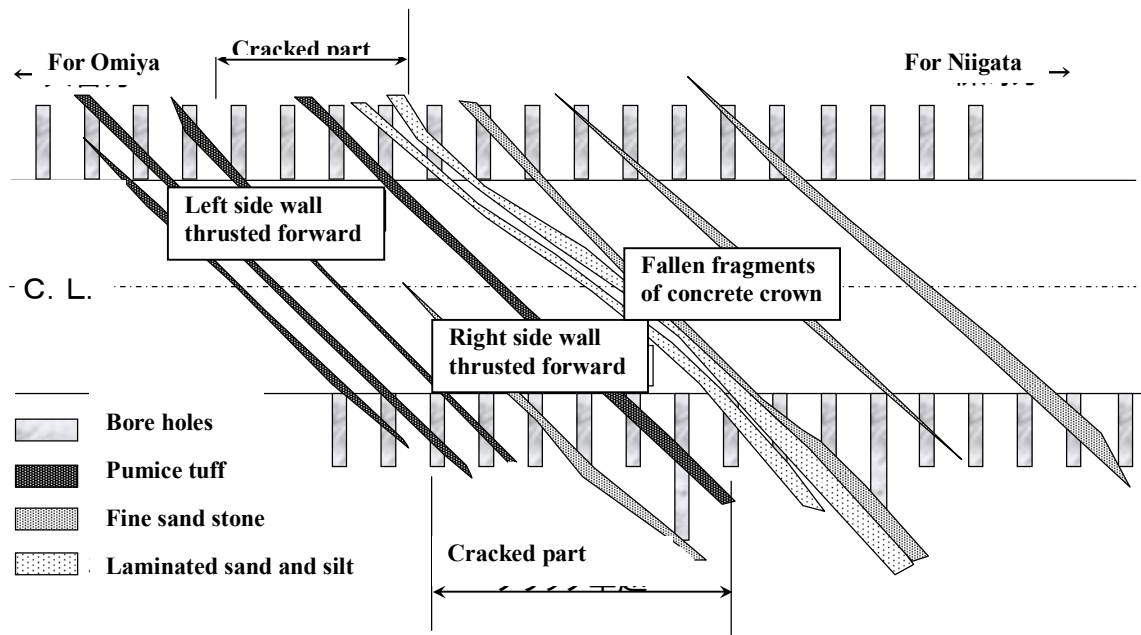
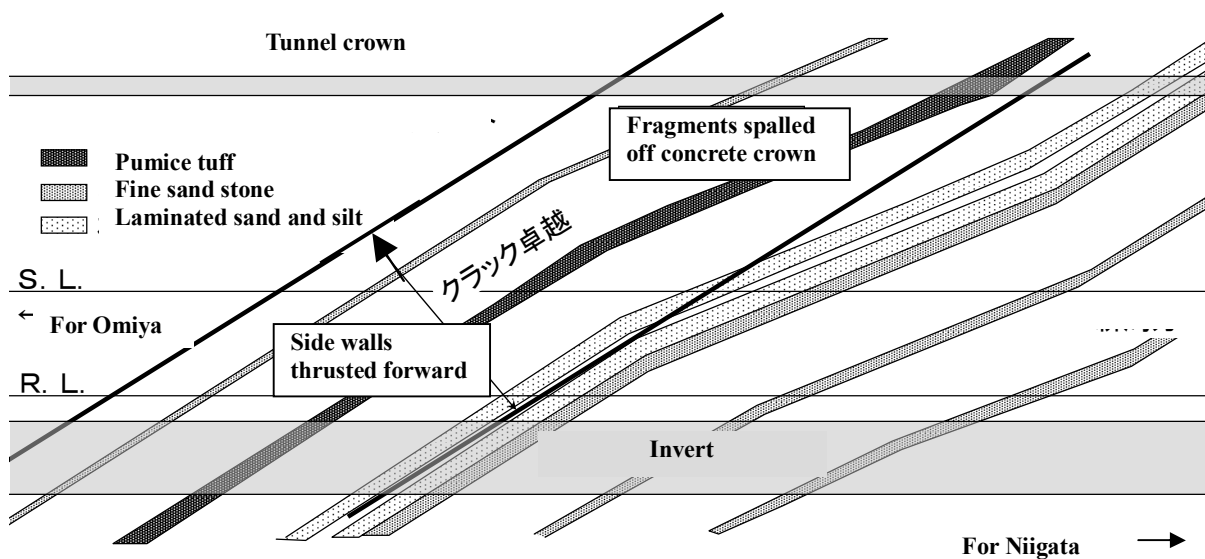
Fig. 3.24: Estimated rock profile behind tunnel lining (JR East, 2006)

Due to the tunnel depth at the damage location the shallow landslides above the tunnel could not have caused the damage. Most likely the tunnel was damaged due to a combination of minor slips on laminated sedimentary rocks crossing the tunnel (See **Fig. 3.24**) and the overall axial compression due to movements on other nearby hidden faults within a belt along Kajigane syncline, which belt was shifted east as shown in **Fig. 3.18(a)**.

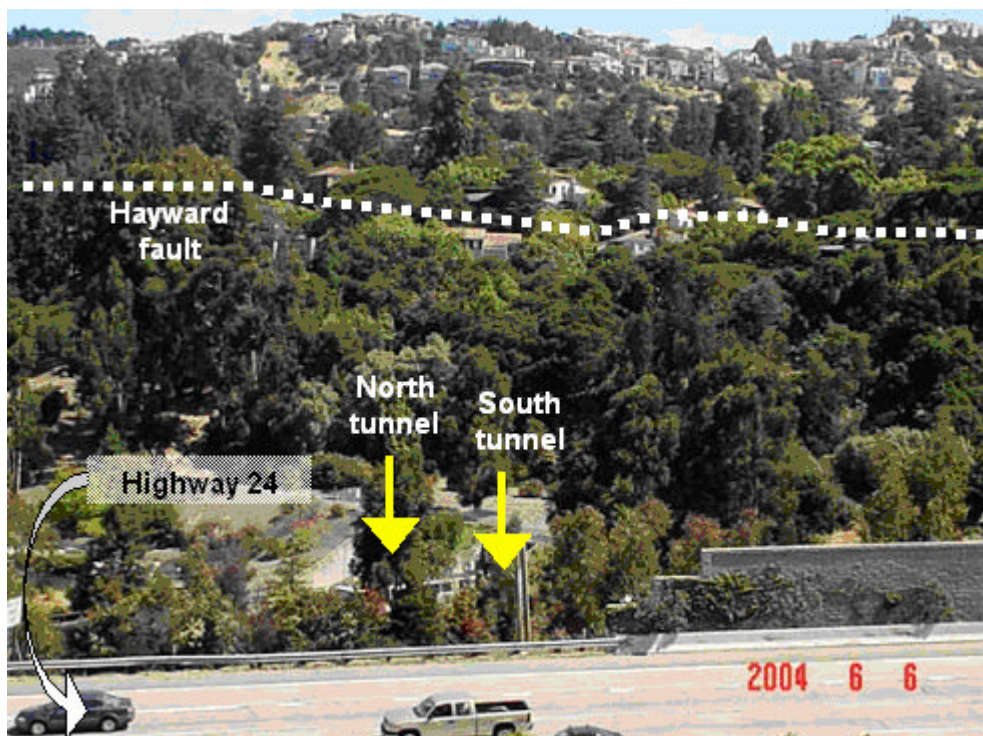
Fig. 3.25: West tunnel mouths of Barkeley-hill BART Tunnel

BART Contra Costa line (C line) leading to Pittsburg bores through the rock of "Barkeley-hill" east of Berkeley (**Fig. 3.25**). The Hayward fault bisects this BART tunnel about 300 m inside from the west entrance. There was a debate erupted when USGS issued a press release indicating potential for damage to structures along the Hayward fault. BART has carried out careful alignment surveys of the tunnels since their completion in 1968. The extensometer measurements were continued in the fault zones and eventually, it was found that the total 80 mm dislocation due to the right-lateral strike slip had been built up over 10 years (1971-1980) in the north tunnel; There are 2 bores, each about 22 feet in diameter, spaced 50 feet apart and linked with pedestrian cross-tunnels at a regular interval of 1000 feet for emergency evacuation. By that time (1979) low angle cracks were visible on the lining of the tunnels, suggesting the compressional force along the tunnel axis (**Fig. 3.27**).

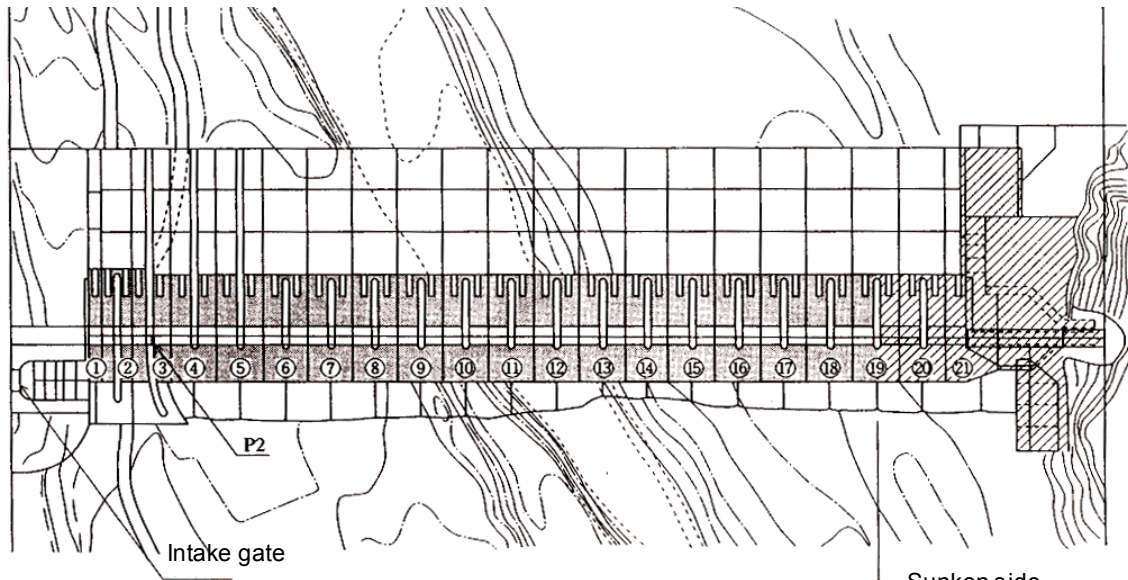
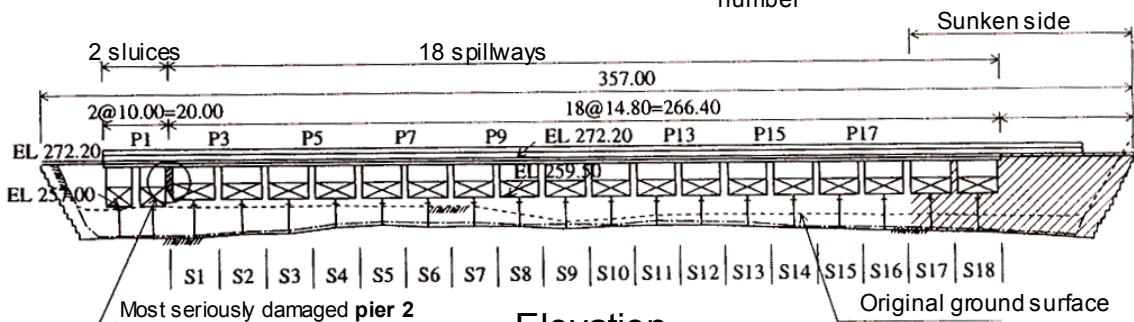
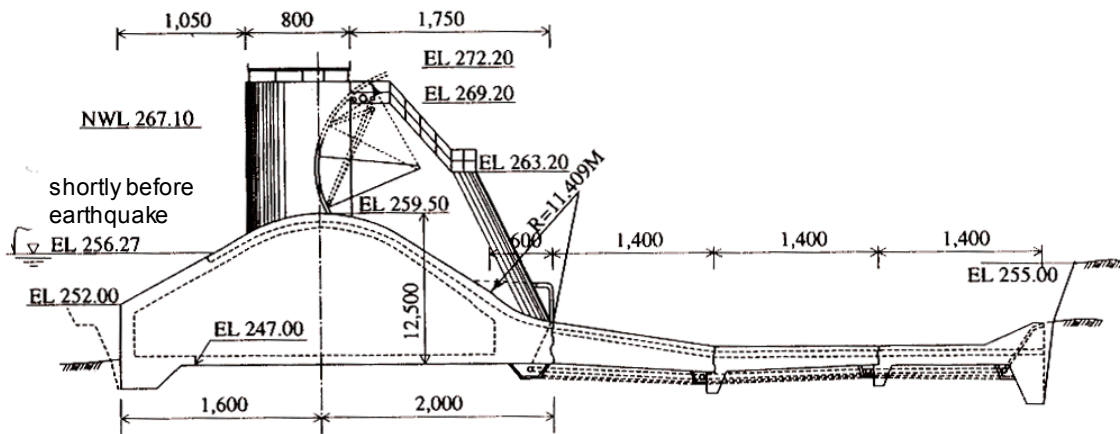
Fig. 4.6: Shih-Kang Dam

The Shih-Kang Dam, 25 m tall and 357 m long with 18 gates lined up, has a total concrete bulk of 141,300 m³ (**Fig. 4.6**). The reservoir with a capacity of 3.38 million m³ collects water from a catchment area of 1,061 km² in the Chung-Yang Mountains, and provides a steady supply of water for irrigation, etc. An intake tunnel on the left abutment of the dam leads the water through a diluvial terrace down to the Feng-Yuan water-treatment plant.

As was shown in **Fig. 4.6**, the dam is made up of 21 blocks whose numbers are put in circles in **Fig. 4.6 (top)**. A pier sticks upright in the middle of a block, and a pair of blocks put side by side forms a spillway or a sluice. As is illustrated in **Fig. 4.6 (bottom)**, all 18 spillways are equal in their cross-sections; 12.5m high and 36m wide of bulk concrete. There are two sluices on the left side of the dam.

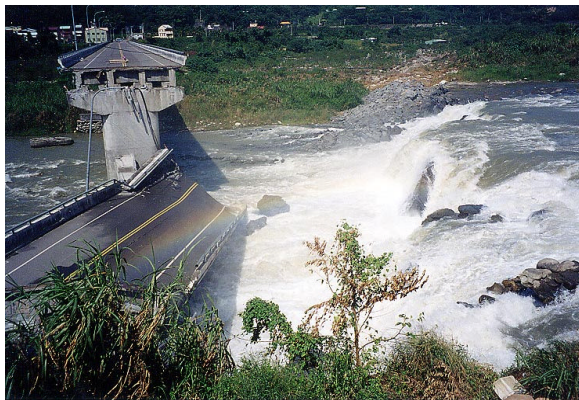
Fig. 4.8: Bei-Fong bridge and fault-created Waterfall

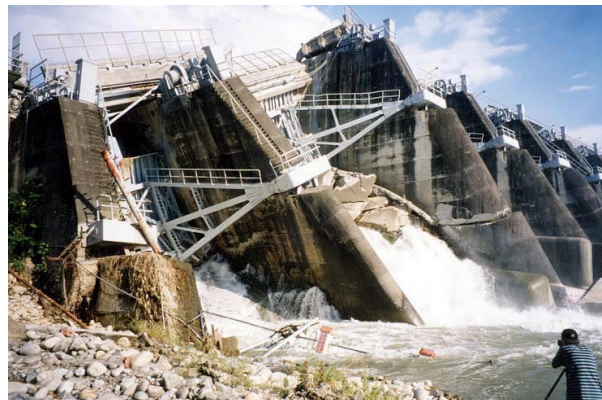
Fig. 4.9: Broken spillways of ShihKang dam

As has been mentioned, the fault rupture planes appeared branching east off the recognized trace of the CheLungPu fault in the vicinity of Feng-Yuan City, and crossed the Shih-Kang area. The complicated features of this fault rupture emerge as one zooms in on the Shih-Kang area. Thick contour lines in **Fig. 4.7** show the ground upheaval in ShihKang. In this figure, line *A* forms a part of the northeast extension of the CheLungPu Fault. Line *A* crossed the Ta-Chia river near the Bei-Fon bridge, where the southeast side of the fault rose up by about 6 m with respect to the other side, causing a water fall to appear (**Fig. 4.8**). This line, however, dies out as it climbs the north hillside, and another line, *C*, appears abruptly several of hundred meters east off Line *A*. Line *C* crossed the northern end of the Shih-Kang dam causing three spillways of the Shih-Kang dam (No. 16-18) to be destroyed (**Fig. 4.9**). The vertical offset of 10-11 m was reached at this point.

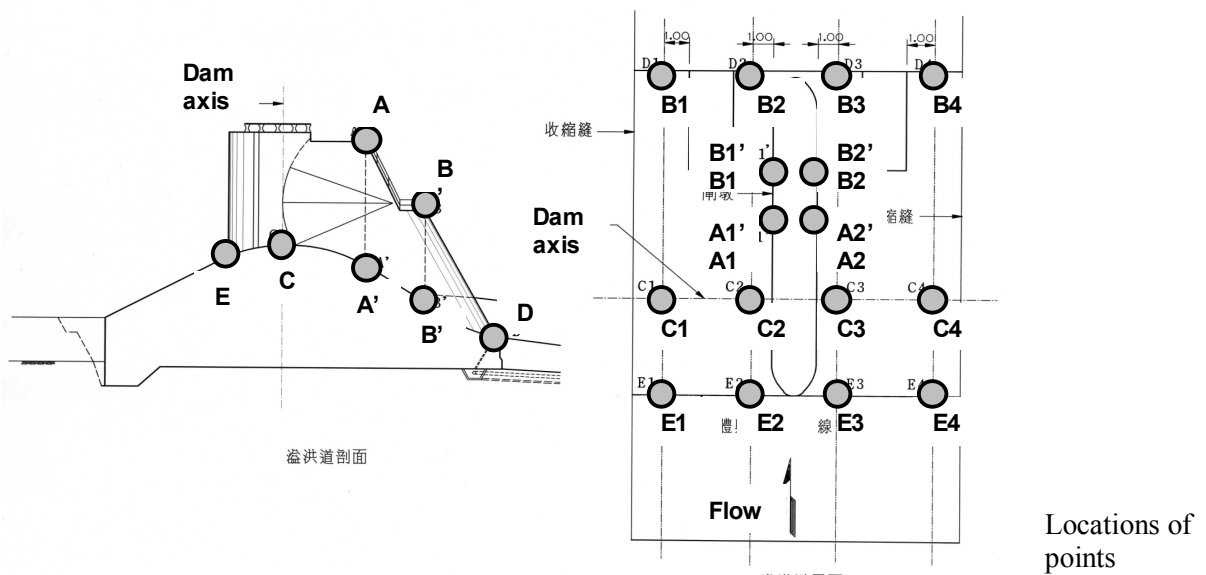
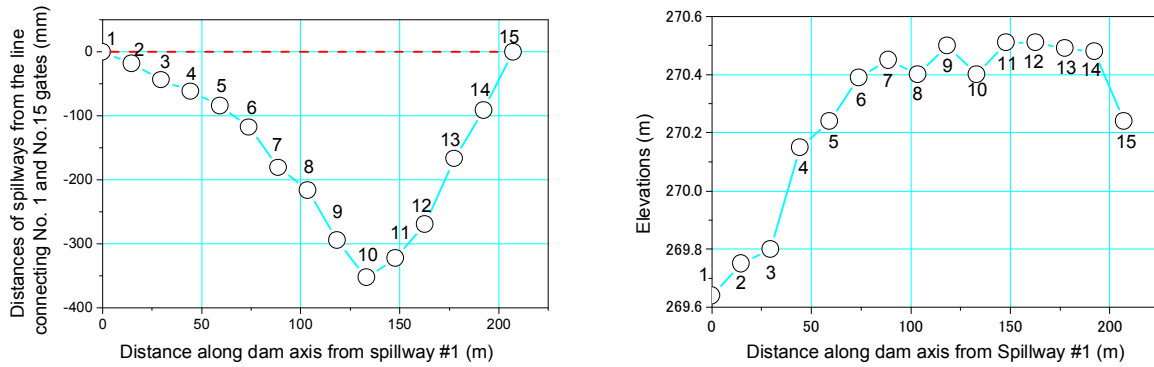
Fig. 4.10: Deformation of dam body along its axis

Kung (2001) measured elevations of total 312 points on the dam body (**Table 4.1**). **Fig. 4.10** shows the deformation of dam body along its axis measured shortly after the earthquake. Horizontal distances of spillways were measured from the line connecting Spillways #1 and #15. Though the vertical elevations are not completely identical with those (C points) listed in Table 2.2, the deformation pattern in **Fig. 4.10** and that from Table 2.2 (Kung, 2002) are about the same in shape and size. The entire dam body thus seems to have been warped both upward and towards upstream side.

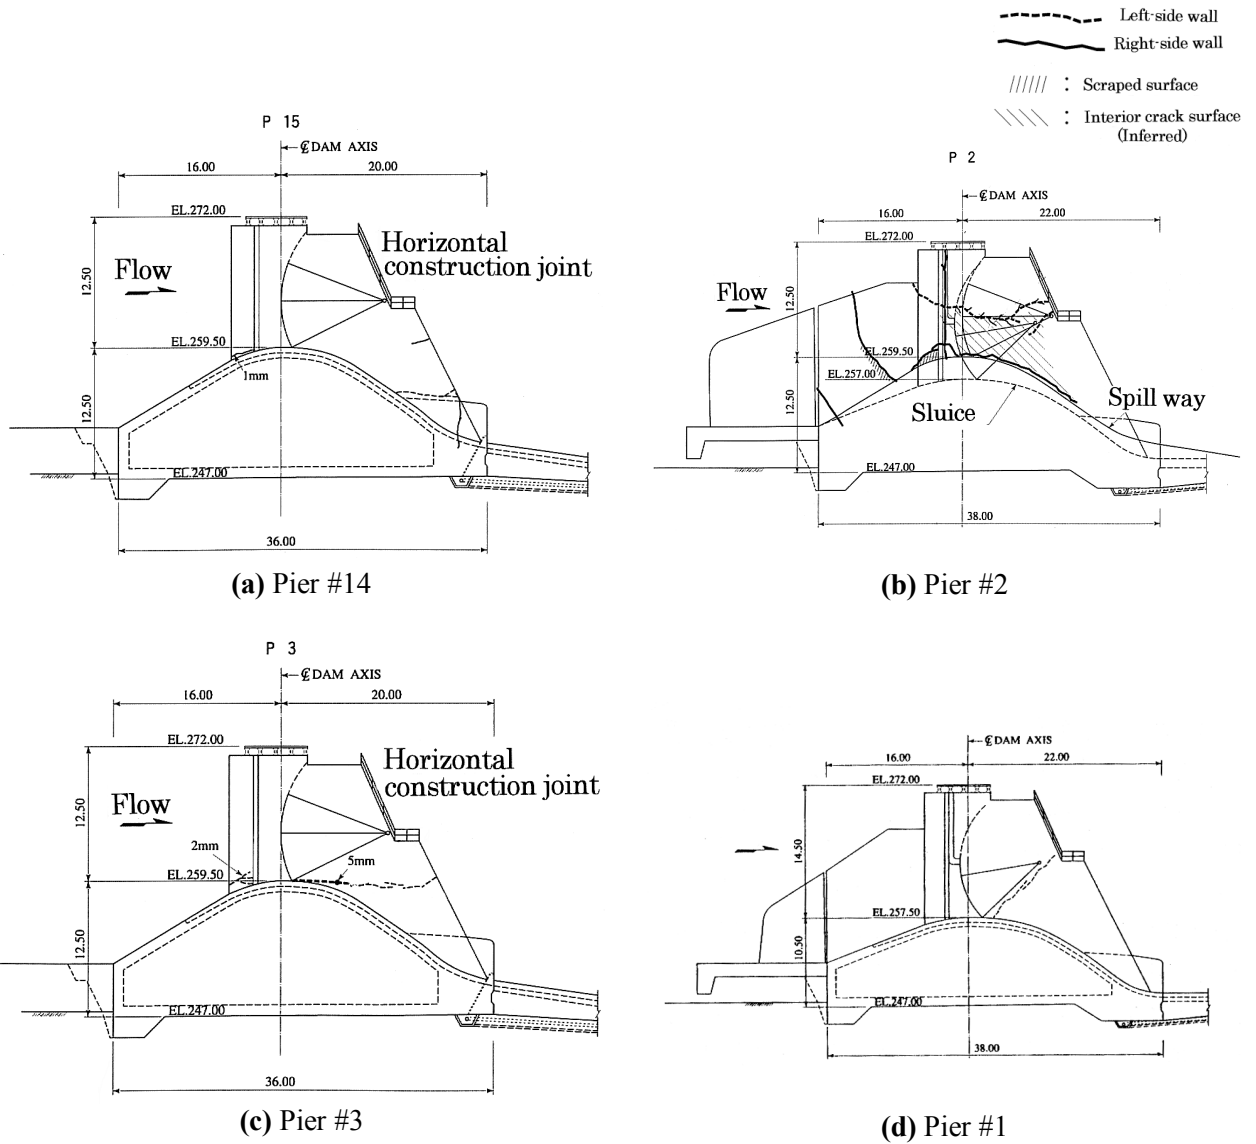
Diagonal cracks on blocks ⑨, ⑩, ⑪, ⑫, ⑭, ⑯, ⑰ and ⑱ reach the piers, and the crack on Block ⑪ further extends diagonally up through Pier 10 (see **Fig. 4.12(e)**). The largest crack openings of 20 mm, 8mm and 40 mm are reached on Block ⑪, Pier 10 and the block joint between ⑩ and ⑪, respectively (see **Fig. 4.12(e)**).

(e) Cracks extending diagonally up through Pier #10

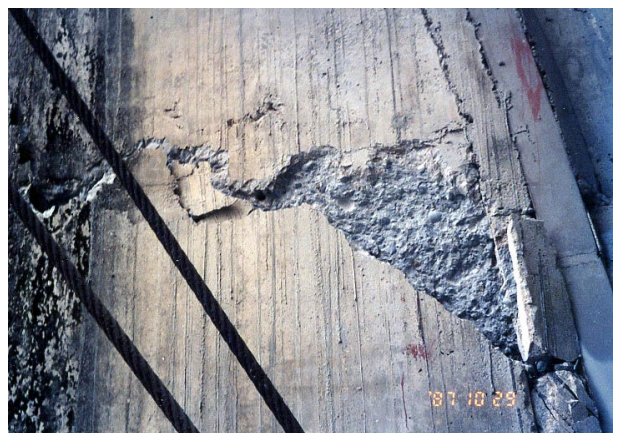
Cracks along horizontal construction joints were found on four piers #9, #10, #15, #16 and #17. No major cracks were found on blocks more than 200 m away from fault C. In this less-damaged part also, Piers #1-#5 were found to be cracked. The cracks on Piers #1-#5, however, have some different features from those found on the piers closer to fault C. Some small fragments of concrete came off a jagged horizontal crack on the sluice-side wall of Pier #2 (**Fig. 4.12(b)**), and the rupture surface inferred from the cracks seems to run diagonally down through this pier to the other (spillway-side) wall of the pier. It is noted here that the concrete bulk of the sluice is 2.5m higher than the next spill way.

(f) Pier #2

Fig. 4.12: Cracks on dam piers

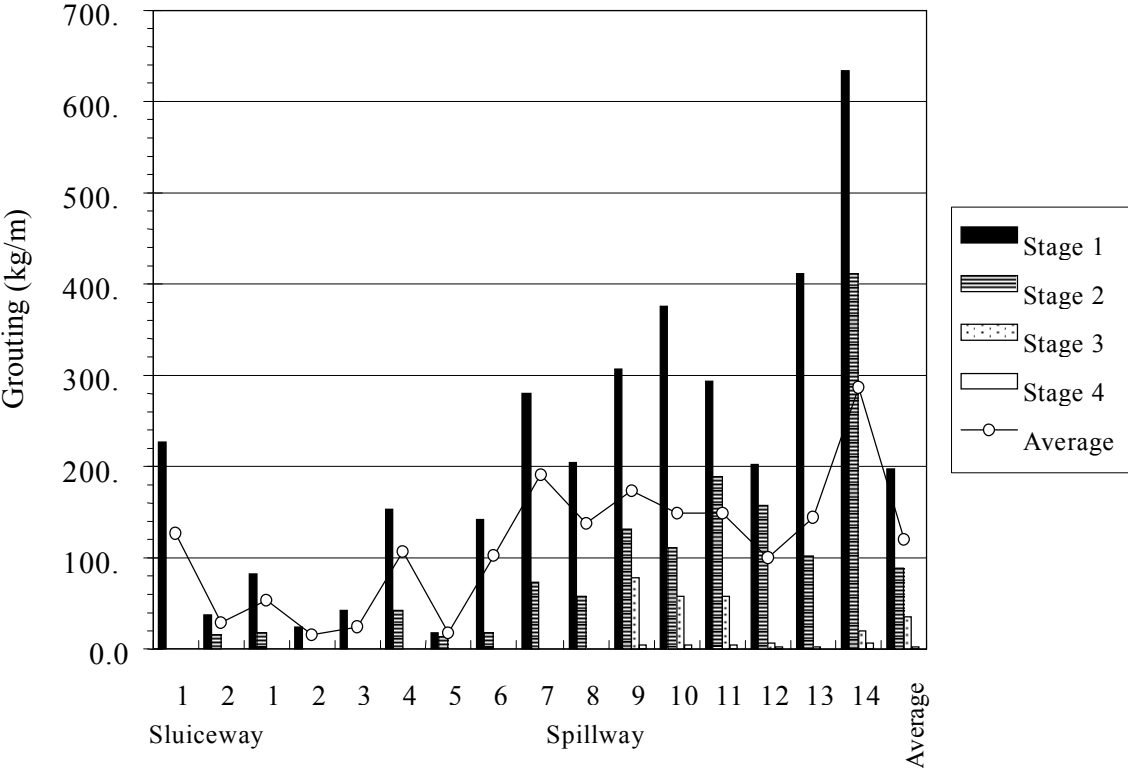
Fig. 4.13: Variation with the axial distance of the volume of grout injected (Kung, C.S., 2000)

However, the base rock deformation may not be the sole cause of the dam body deformation. It was an urgent task to restore the water supply function and to provide necessary flood control for the coming flood season. Therefore, grout injection was carried out for the remaining gates, preserving the completely damaged gates as a memorial park. Fig. 4.13 shows the variation with the axial distance of the volume of grout injected. A noticeable amount of grout was poured into hidden cracks in the right side of the dam body; this suggests that this part of the dam body may have come off the base sedimentary rock due to a large axial force induced in it. This may have made the upheaval of the dam body even more remarkable.

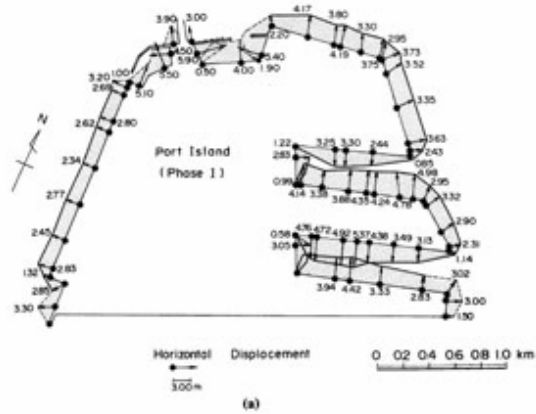
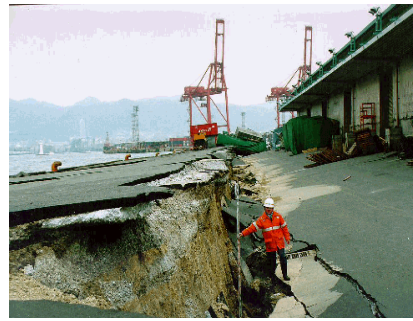
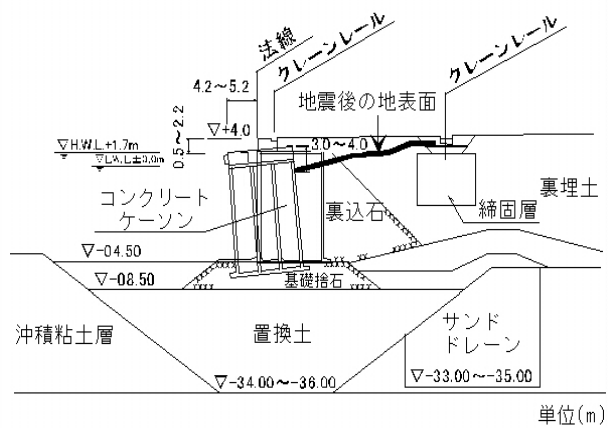
Fig. 6.4: Displacements of quay walls at Port and Rokko islands and typical damage example with settlement of backfill (Inagaki et al., 1996).

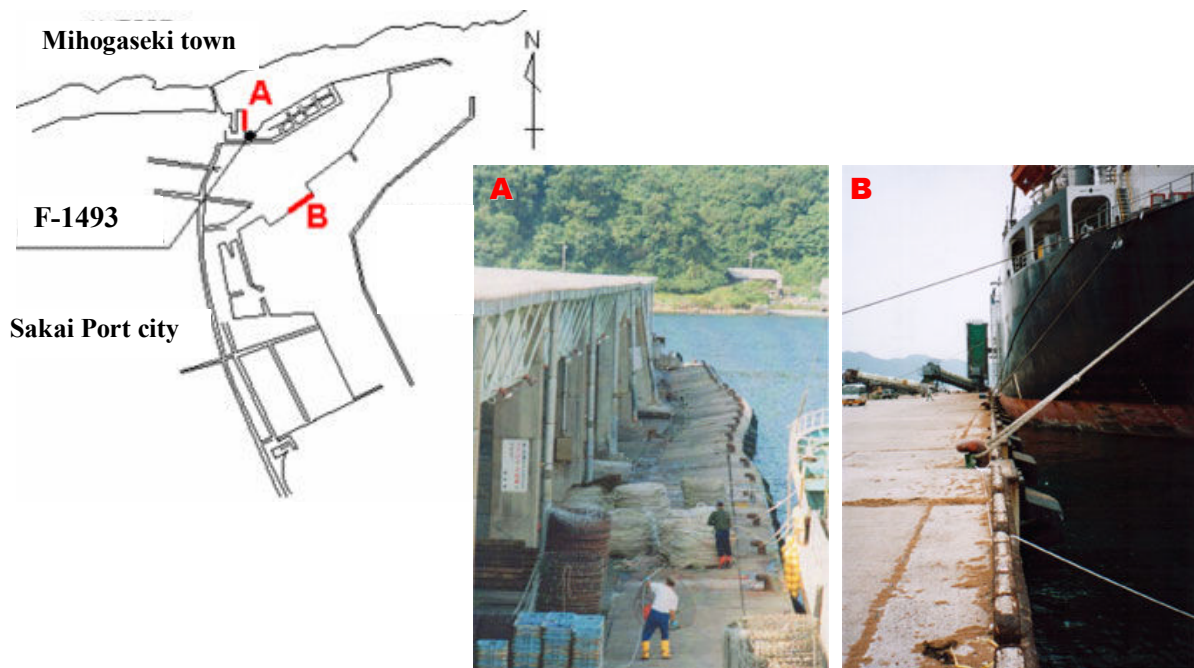
Fig. 6.6: Displacements of quay walls at Sakai Port: Displacement is larger at Point A than that at Point B. (“Handbook for designing port facilities reflecting seismic directivity (CD ROM),” Port and Airport Research Institute, 2003).

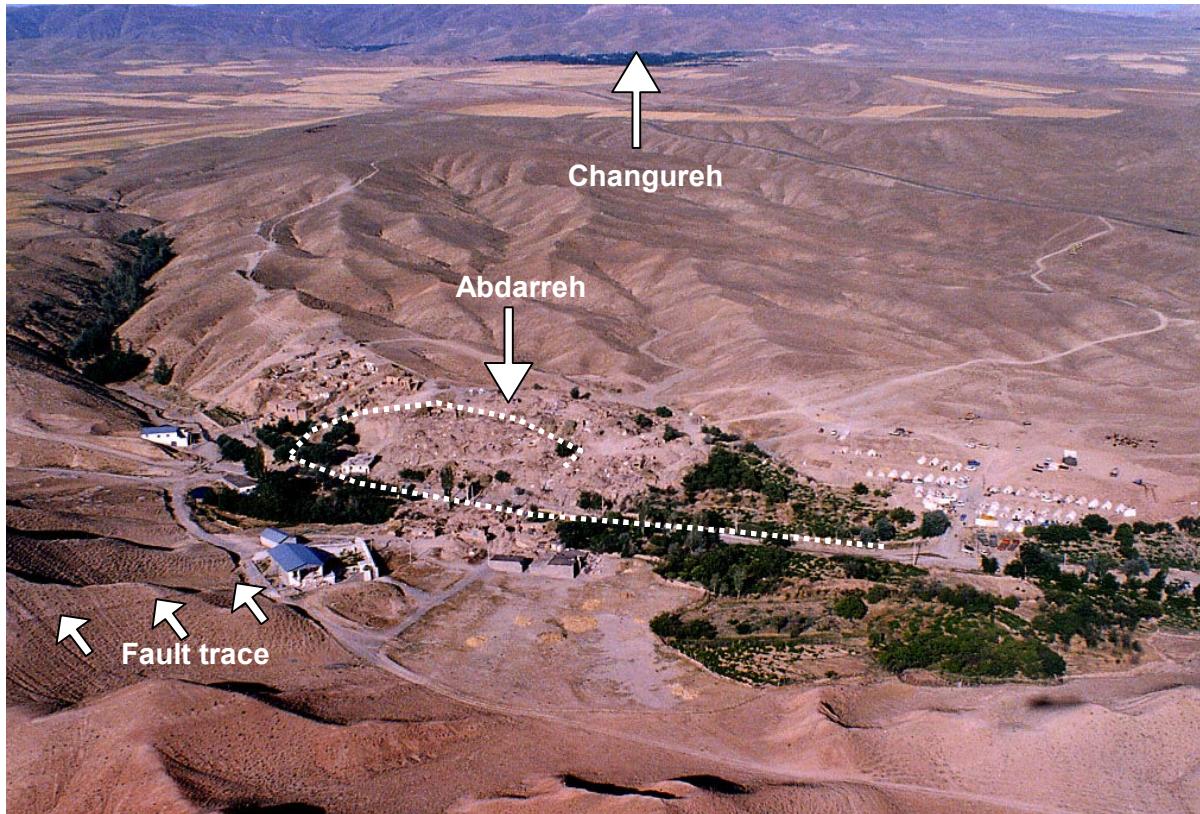
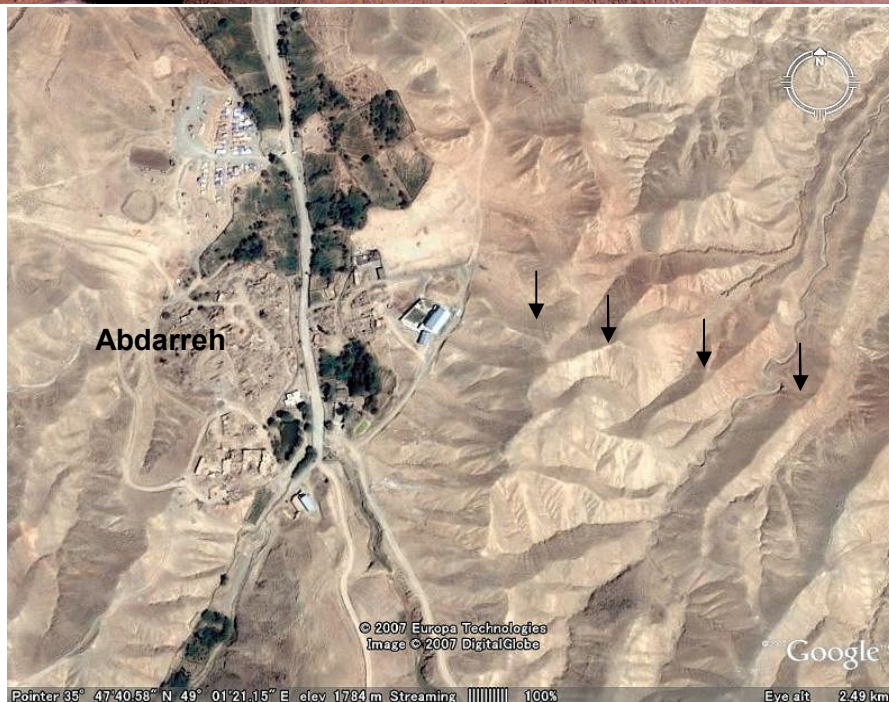
A surface fault related to this earthquake appeared across the epicenter area of the main shock. According to Sassan, Eshighi, Mehdi Zare and Mohammad R. Mahdaviyar, IIEES, surface fissures are continually lined up 3 km straight across the barren terraces between Changureh and Abdareh (Fig. 6.9).

An about 700m part of the surface fault extending east from Abdareh was traced. The rupture runs straight across the mountain ridges, and is related to the compressional mechanism. The southern hanging wall side has been pushed about 5-10 cm up. This trace of the fissures trends $N70^\circ W$, and is approximately orthogonal to the axis of the focal solution for this earthquake given by NEIC and Harvard University (2002).

Fig. 6.9: Surface fault trace and affected areas

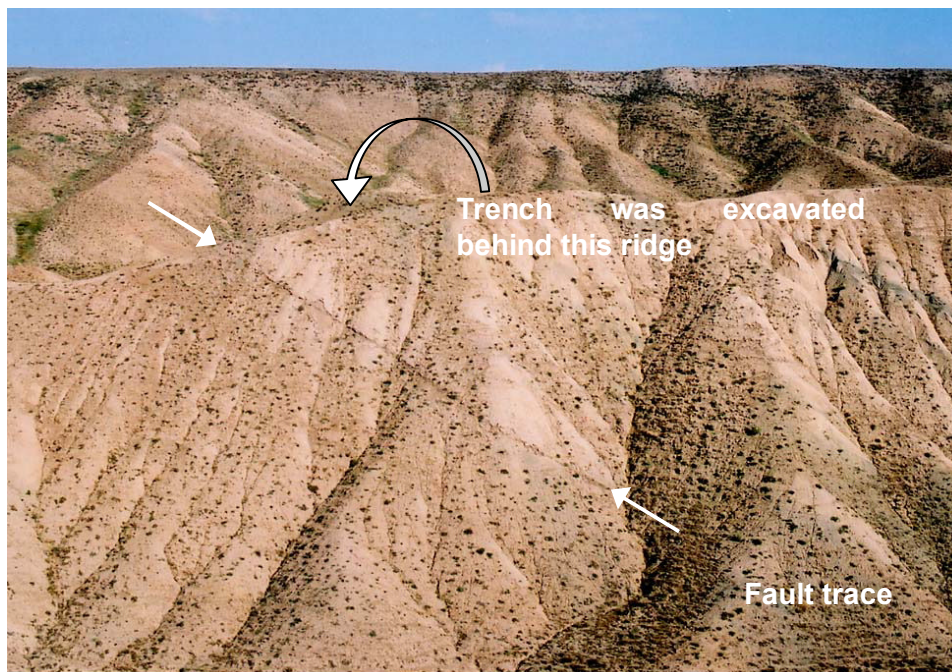
A trench was excavated at a narrow valley approximately 500 m east of Abdarreh (Fig. 6.10). The site was chosen in expectation of finding charcoals that would allow dating possible previous events. Since the location was inaccessible by any machines, the trench was dug by hand, and was 3 m wide, 5 m long and about 1.2 m deep with east and west side walls cutting straight in the middle of the valley and along the mountainside (Figs 6.11, 2.12).

Fig. 6.10: Surface fault trace and location of trench
