Infrastructures near Seismic Faults

Infrastructures near Seismic Faults: Data archives prepared by the Technical Committee for Fault-related Geotechnical Issues about Civil-infrastructures, Japan Geotechnical Society (JGS).

REPORT OF JSPS RESEARCH PROJECT
2006 GRANT-IN-AID FOR SCIENTIFIC RESEARCH (A)
Project No. 16208048
Title of the Project:

Key Points for Rational Design for Civil-Infrastructures near Seismic Faults Reflecting Soil-Structure Interaction Features

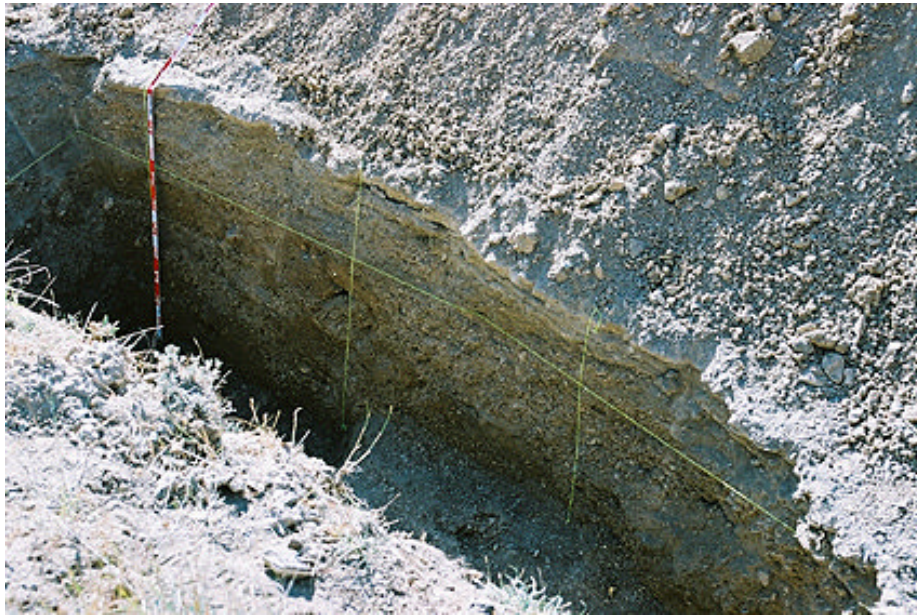
Fig. 6.11: Excavated trench

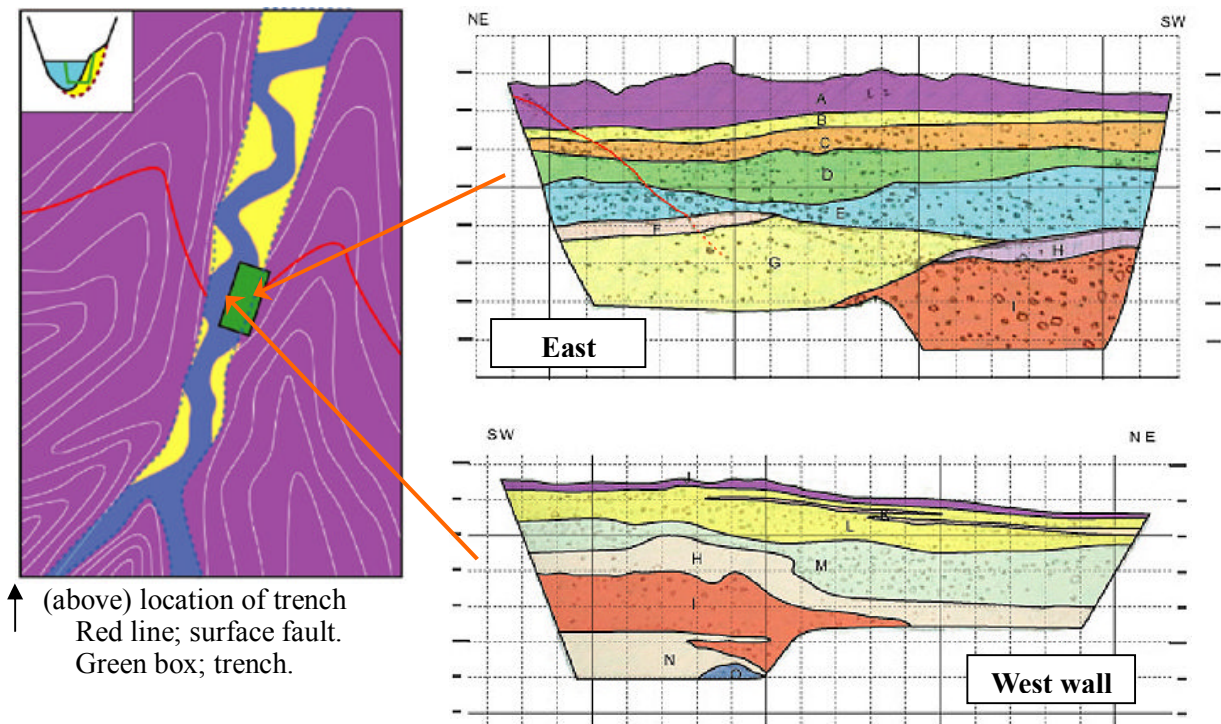
Fig. 6.12 shows a sketch of the east and west walls of the trench. Layer A is the weathered soil covering thin both the mountainside and the valley. Layer B is composed of granule and less matrix. Layer C contains semi-angular pebbles. Layer D is a matrix rich bed. Maximum grain size of 2 cm is reached in this layer. Layer E is a clearly imbricated gravel bed. The average and maximum gravel sizes are about 1 cm and 5 cm, respectively. Layer F is a paleo-soil covering a gravel bed of layer G. Layer H is also a paleo-soil bed, but is overlain by gravels of layer G. Layer I is a gravel bed covered by layer H. Maximum gravel size of layer I is about 5 cm. Layer F, G, H are overlain by layer E with unconformity. The fault found clearly from surface to layer E. It is recognized as open rupture and there is no displacement along the fault. In the layers below layer F, the fault is hardly recognized.

On the west-side wall, layer H and I are considered to be extensions of those on the east wall. The uppermost bed of the valley sediment, layer J, is a sandy soil with much matrix. Layer K is a thin bed of silt or very fine sand. Layers L and M are sand and gravel beds. The matrix is rather rich in layer L than layer M. Layers N and O are paleo-soil and gravel beds overlain by layer I. Though the surface fissures lined up across the valley have clearly proven the presence of the fault at the slope foot, no clear fault dislocation was observed on the west-side wall probably because the strain caused by the faulting has spread over the uncemented soil. Nothing indicating previous fault dislocations was found in the trench.

Fig. 6.12: Illustration of trench. (by Azuma, Goto, Konagai, Sadr 2002)

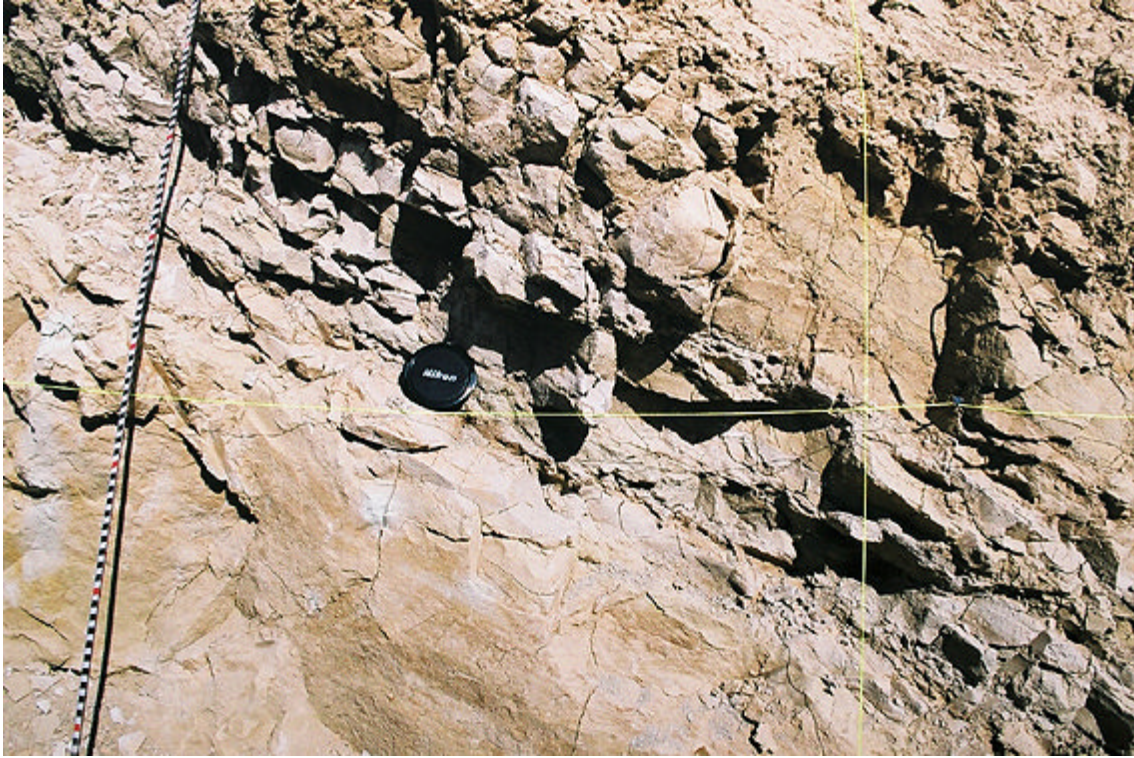
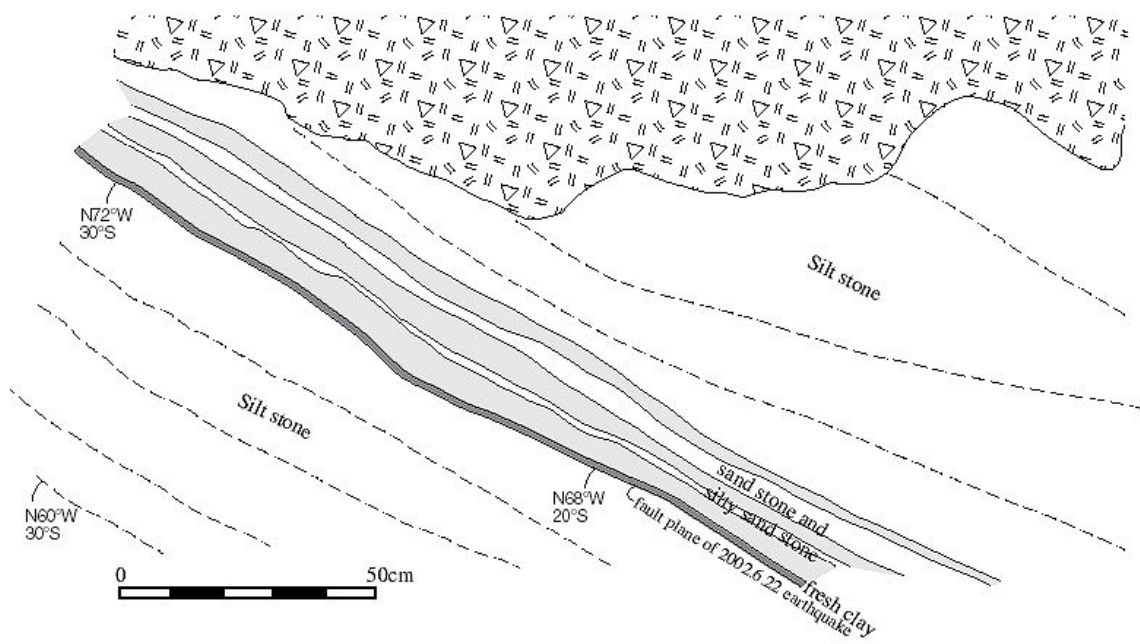
On the east edge of Abdarreah, surface soil was scraped off to observe the fault trace on a silt rock (Figure 2.30). The silt rock dips to south. Tufficious fine sand and silt film is caught thin in the silt rock and faulting occurred on its bedding plane. Most southern part of the tufficious sand has developed into clay of 2-3 cm thick probably because of the continual fault dislocations. Siltstone among the thin tufficious sand film has been weakened.

A “bedding plane fault” can be considered as a by-product of folding, and causes a moderate earthquake of M6 class.

Fig. 6.13: Exposed surface of silt rock (photo by Goto)

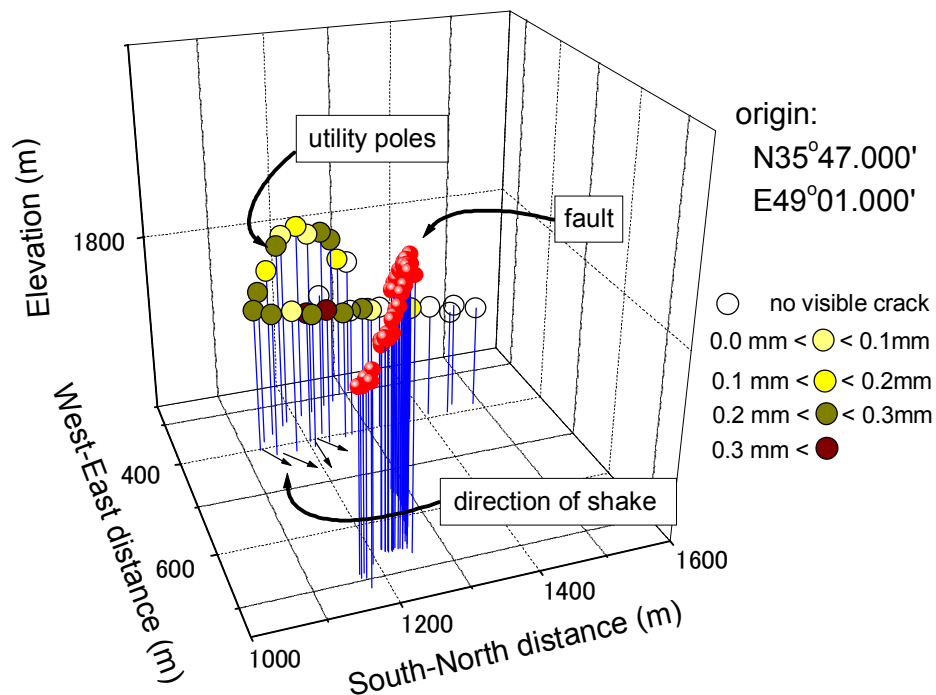
- Group 1:** no visible crack. (White)
- Group 2:** with hair cracks (>0.1 mm, Light yellow)
- Group 3:** with cracks (0.1-0.2 mm, Yellow)
- Group 4:** with cracks (0.2-0.3 mm, Dark yellow)
- Group 5:** with cracks (<0.3 mm, Brown) that can be seen at a distance of about 2m

Fig. 6.14 shows the observed distribution of crack intensities. In this figure, the route taken for the inspection is lined up with the utility poles (colored circles). The route goes straight from right to left along a valley, and turns sharply up towards the ridge when it reaches the southern edge of the village. Then it comes slightly back along the ridge. Several arrows near the bend of the route indicate the inferred directions of strong ground motions. The other line of dark sphere marks is the fault trace. It goes across another mountain ridge that rises east of the village, and meets the route. It is noted that the fault trace seemingly divides the utility poles into two groups; cracked poles on the hanging wall side and less damaged on the foot wall side. This clear contrast suggests that the shake on the hanging wall side must have been more intense than that on the foot wall, and thus must have been responsible for serious destruction of the village. The arrows show that the motion was intense in the normal direction to the fault trace.

Fig. 6.14: Locations of cracked utility poles

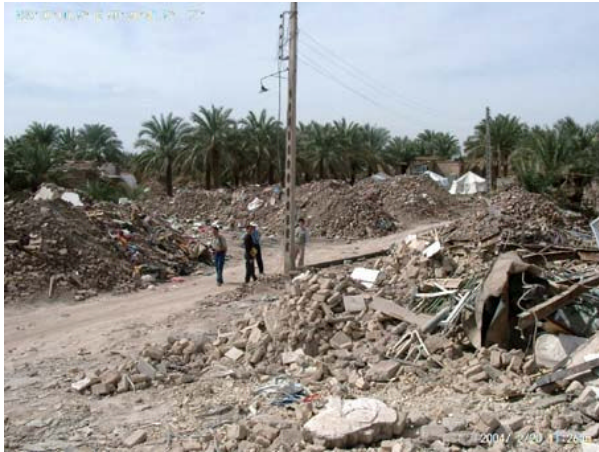
(a) Near the main avenue
29°07'00.5"N 58°21'41.5"E

Fig. 6.23: Damage to dwellings in Bam

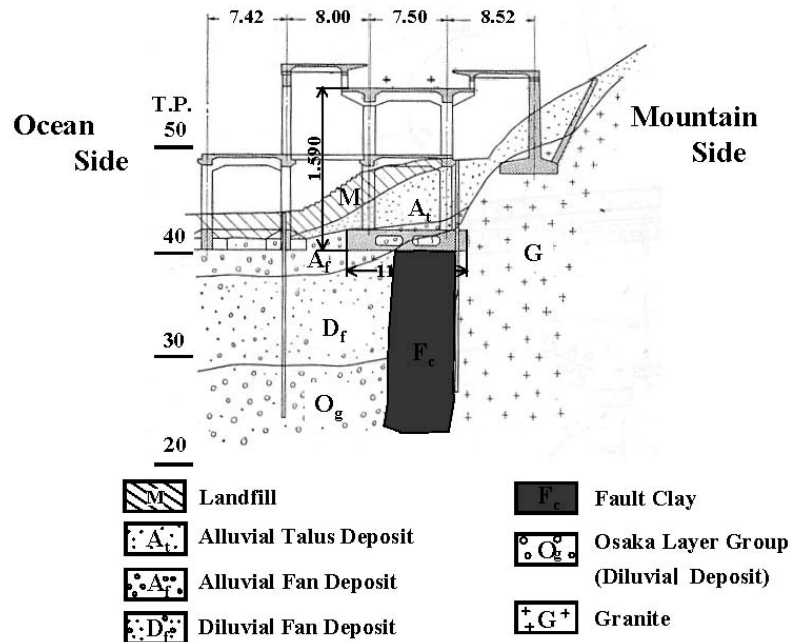
During excavation for the construction of the foundation of the Shinkansen Shin-Kobe station an active fault was found as shown in figures 22 and 23. However, it was impossible to change of the location of the station and of the route because of the limited construction space and time. The vertical fault movement was estimated to more than 0.7 meters during the last ten thousand years from geological inspections and the possible fault movement during the lifetime of the elevated bridges was estimated to less than 5cm. In order to allow for this fault movement, movable shoes with a maximum displacement capacity of 15 cm were installed between the platform structures and railway bridges as shown in **Fig. 7.7**.

Fig. 7.6: Cross section of Shin-Kobe station showing the location of fault clay from Hamada (2003) after Morishige (1970)

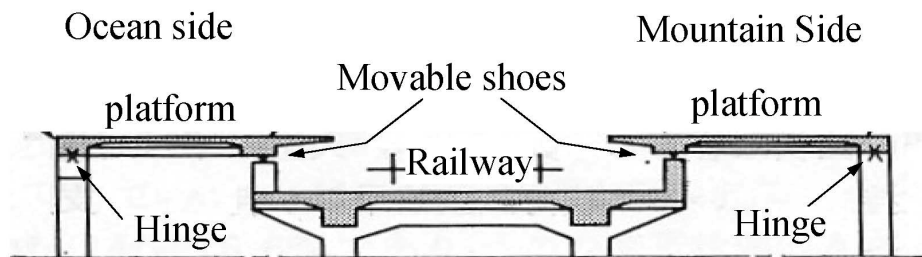
Fig. 7.7: Drawing of Shin-Kobe station showing the location of fault clay from Hamada (2003) after Morishige (1970)

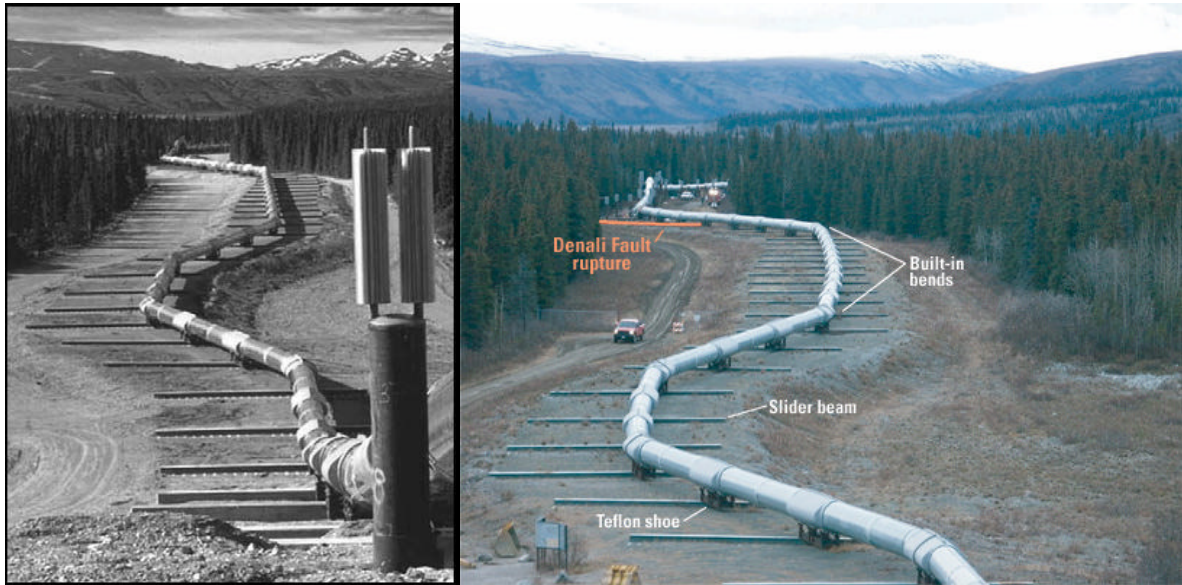
Though pipeline fault interaction is only partially related to the current study this section was included because of the great performance of the Trans-Alaskan pipeline during the Denali fault earthquake showing that through thorough geological investigations and clever design, important lifelines can be constructed to survive a large fault induced deformations (**Fig. 7.12**).

Fig. 7.13: Trans-Alaskan pipeline at the Denali fault crossing (Hall et al., 2003)
Photo right: US Geological Survey Fact Sheet 014-03 (2003)

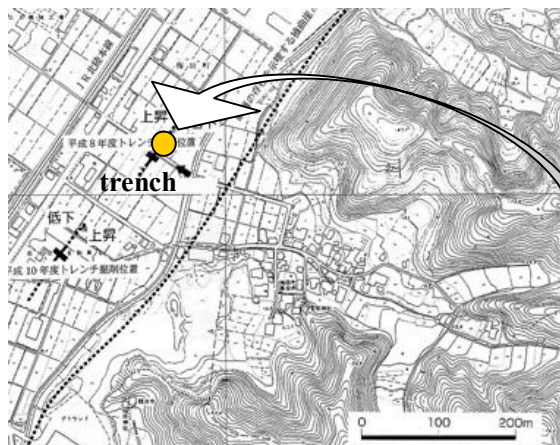
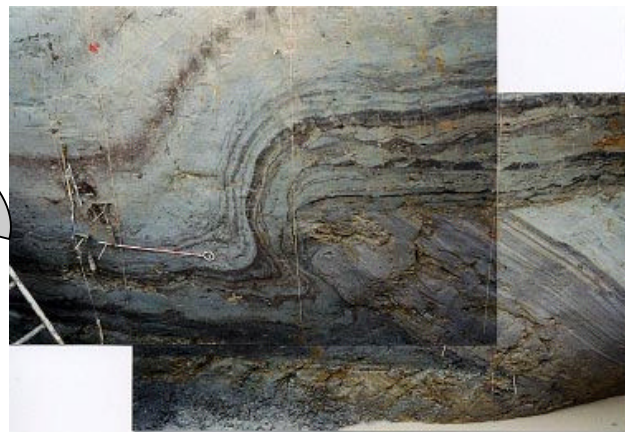
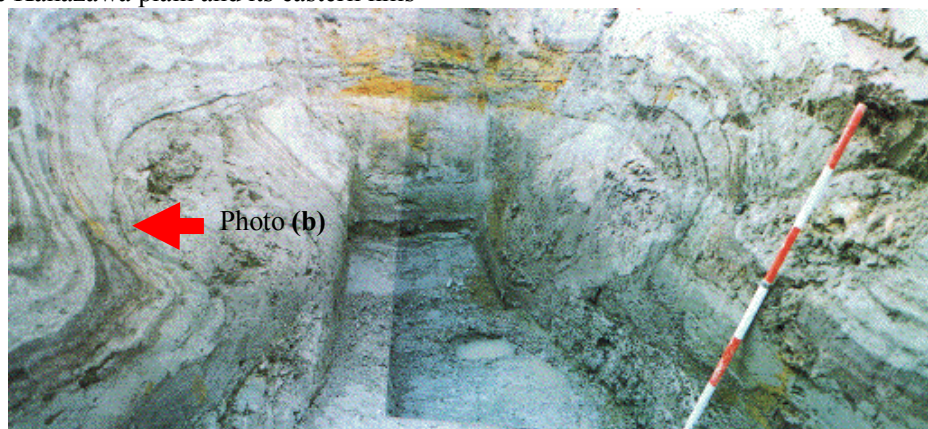
Fig. 8.3: Trench excavated across Morimoto fault (N36 37'28", E136 42'15")

Fig. 8.3 shows the location of a newly found Morimoto fault trace and photos of a trench excavated across it. The fault was found about 100 m off the estimated linear boundary (broken line in **Fig. 8.3(a)**) between the Kanazawa plain and its eastern hills. A base mud rock is cutting sharp into an overlying soft soil deposit, while the soil deposit is gently bent over the base rock wedge. Before the trench excavation, there was no clear evidence on the ground surface indicating the presence of this hidden fault. It is noted here that the right-hand side of the base rock (hanging wall) that had pushed about 1 m up into the surface soil deposit was not on the mountain side but on the flat land side. Assuming that a soil wedge was pushed up and we were looking at just one side of the wedge, this fact suggests the presence of another new fault hidden further away from the mountains, and actually, this new fault was found in 2001 about 500m off the mountains (Nakata and Imaizumi, 2002). This indicates that the width of 300m for the Fault Hazard Zone may not be wide enough.

(a) Location of a fault trace found 100 m off the estimated linear boundary (broken line) between the Kanazawa plain and its eastern hills

(b) South trench wall (Photo by Sangawa)

(c) Trench walls showing seaside-up movement (Photo from Ishiwatari, A., <http://earth.s.kanazawa-u.ac.jp/ishiwata/labo/morimotoUS.html>)

From these mentioned above, a thrust fault zone, along a boundary between mountains and a flat land, may be determined in such a way that **“the zone shall cover about several hundreds meters wide the flat land with the fault trace put aside along the zone’s edge”**. This does not necessarily mean the exterior area on the mountains side is safer than that on the flatland side. As for intense shakes are concerned, it is quite often that the shake is very intense on the hanging wall side. It is also to be noted that soft soil deposits are often responsible for amplifying base input motions. “Earthquake Fault Zones” are just for accounting for considerable deformations of soils.

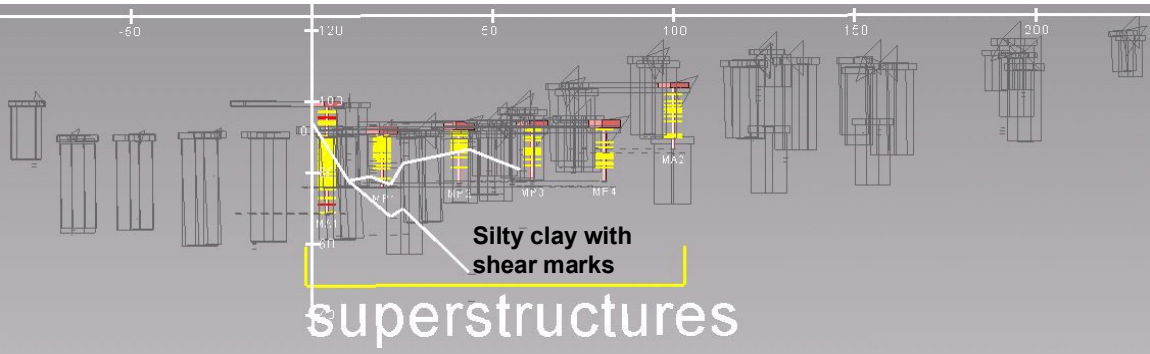
As has been described in Chapter 2, the Bauweishan section of the Highway #3 suffered seismic fault dislocation during its construction. Some pile caps sustained their piers, while the others did not. Many piles loaded with piers were cracked around their top ends immediately beneath their caps, while those without piers did not suffer serious cracking at their top ends (Figs. 8.5 and 8.6). For the latter piles, clusters of major cracks were found rather deeper locations, which were closer to the boundary between the deeper clay layer with sheared marks and shallower and stiffer soil sediment above it (Fig. 8.6). This fact suggests that the piles bearing superstructures can be cracked due to inertia forces from their superstructures, while for those without superstructures, soil deformations can be the major cause of cracking (kinematic interaction).

Taking into account fault rupturing process, the piles could have experienced dynamic inertia interaction first, which was then followed by rather slow kinematic interaction due to fault-induced large soil deformation (see Fig. 8.7). Eventually pile-cap interface cracked due to the inertia interaction can be moment-free, and the pile cap will be moved by the piles experiencing slow and steady soil deformations. To discuss possible pile caps movements near a seismic fault, which movements can affect the function of their viaduct; due attentions should be paid to this scenario.

Fig. 8.5 (same as Fig. 2.17): Location of cracks in cores from piles for the main viaduct piers and abutments looking from south to north in the direction of along the estimated fault trace: Cracks are densely distributed within the surface stratum of natural sand and gravel covered up with fills from the time of construction. These piles sustained piers when the Chi-Chi Earthquake occurred.

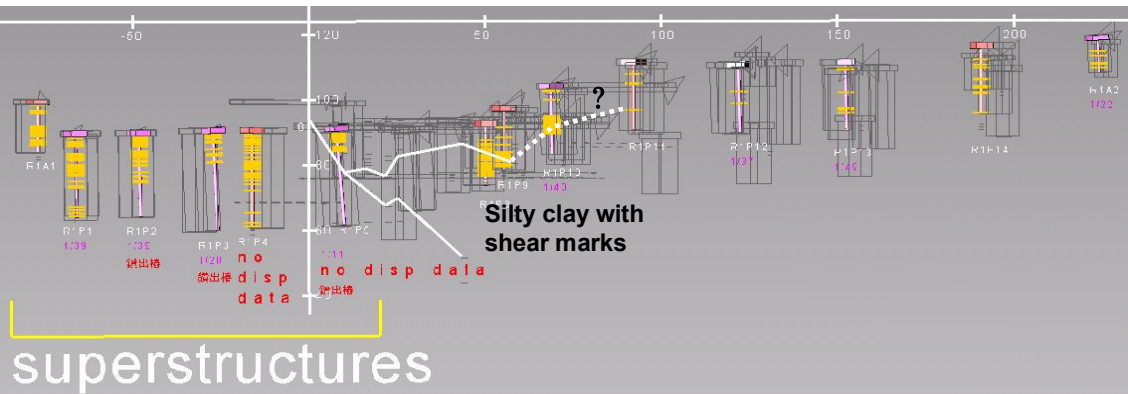
Fig. 8.6 (same as Fig. 8.17): Location of cracks in cores from piles for the Ramp #1 viaduct piers and abutments looking from south to north in the direction of along the estimated fault trace: It is remarkable that piles near the estimated fault, regardless of their locations on either hanging wall side or foot wall side, were severely cracked. However those on the hanging wall side appeared rather deeper locations and seemingly close to boundary between the surface stratum and the silt-clay wedge with shear marks. Note those on the hanging wall side sustained no pier when the earthquake occurred.
